THE SEARCH FOR MAWSONS AIR TRACTOR 2010

Dr Tony Stewart and Dr Chris Henderson

SUMMARY

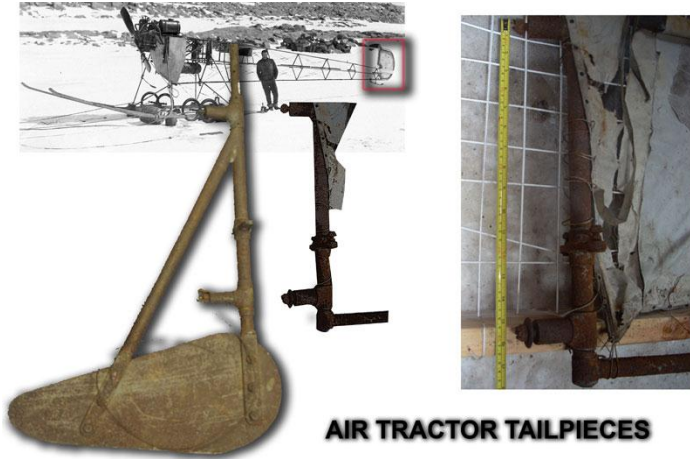
AIR TRACTOR TAILPIECES

The ice rudder whose fittings were identified this year compared here with the fittings on the tailplane stored in Mawsons Hut. The ice rudder was recovered from the harbour in 1976 and is presently stored at AAD Kingston.

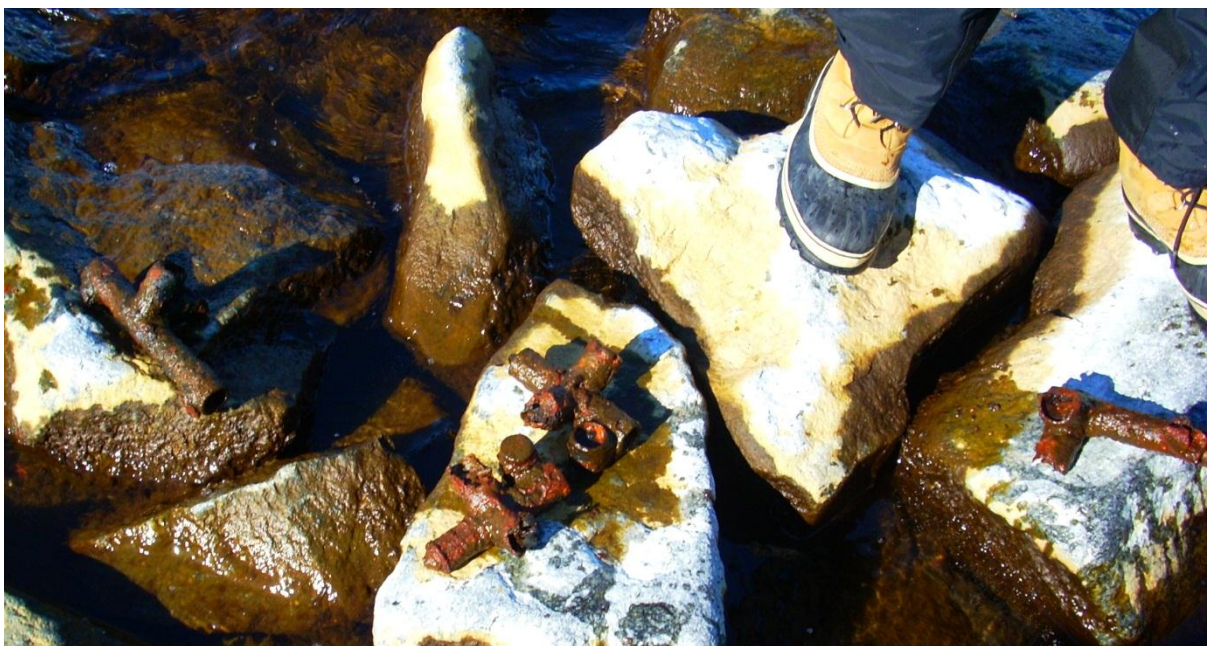
What he actually found was 4 small joining pieces of the last section of the airframe. Each 100-150mm long, heavily corroded and fragile. These were resting among the rocks at the waters edge just below the surface. They have since been recovered and transported to Perth WA in seawater where they will be stabilised over the coming years.

Fragments of the final section of the airframe found in Boat Harbour on 1 Jan 2010

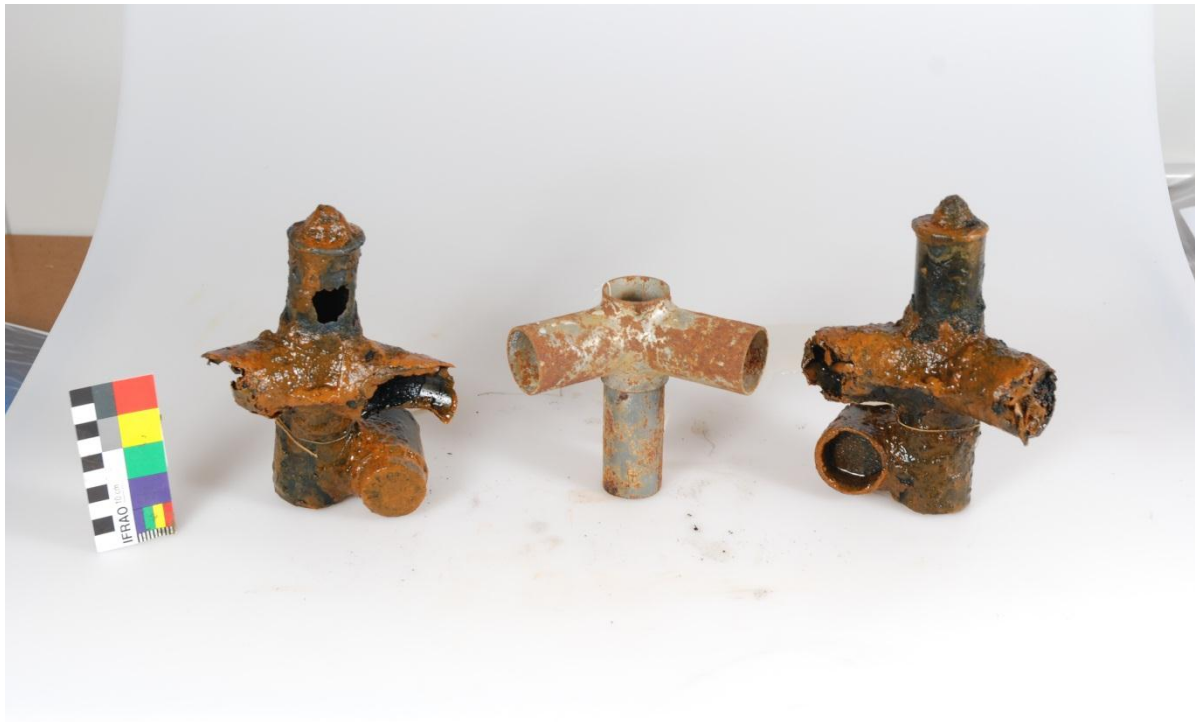
The fragments were readily identified as being joining sections for the modular airframe – most likely from the last segment of the frame since the outer section of the two centre joining pieces have a terminating bolt on one side.

Fragments 1 and 2: Fragments of the airframe compared with existing spare parts from the workshop (centre). The terminating bolts are clearly visible on the top sections of these mirror-image joiners. The round tube at the bottom of both fragments contains wooden dowel which has been sawn off – this dowel is seen in pictures of the intact frame protruding either side of the fuselage.

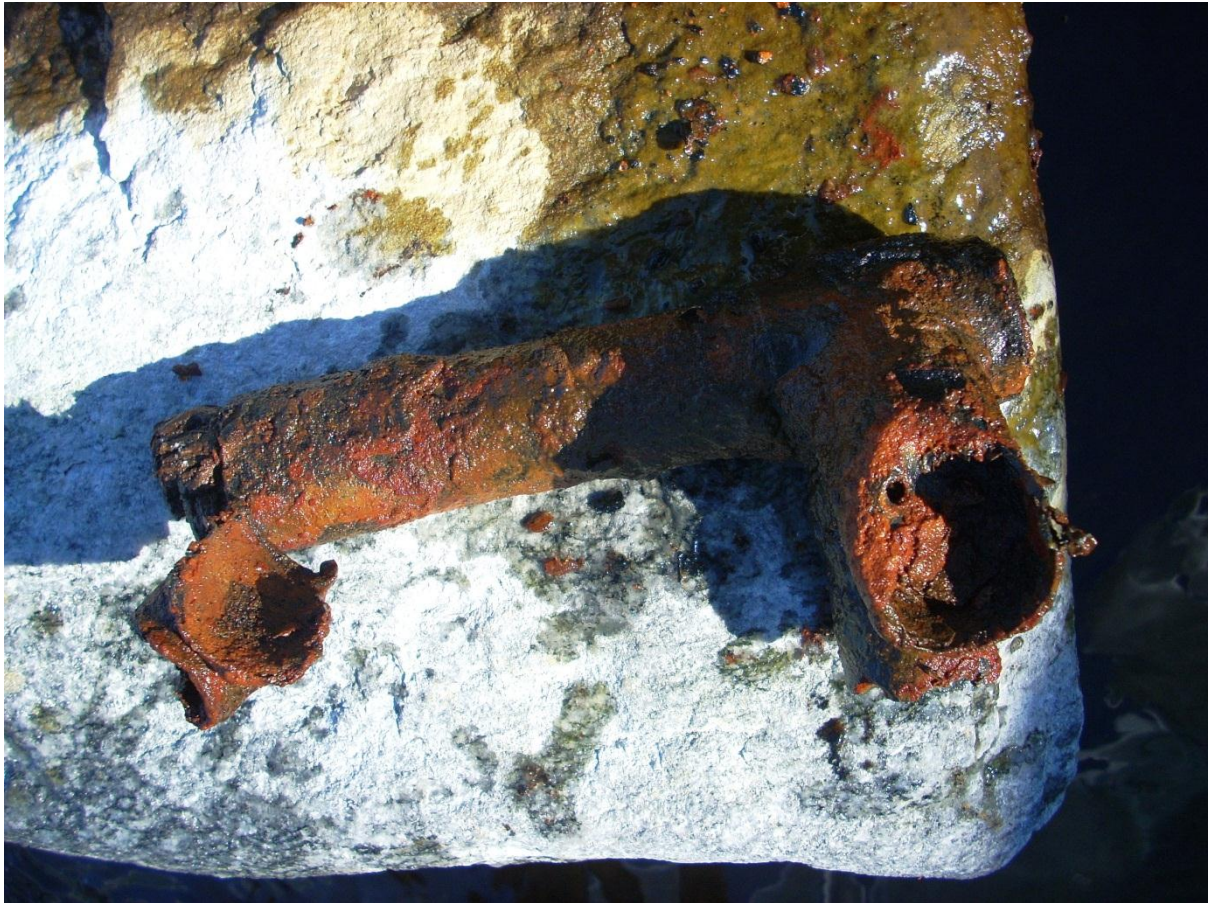
Fragment 3: Straight part from the bottom of the diamond-shaped frame section. It can be seen that a wooden dowel was inserted in the Left hand end, and subsequently cut off , and that there is a round section on top of that end, probably the remnants of a socket for the tail assembly.

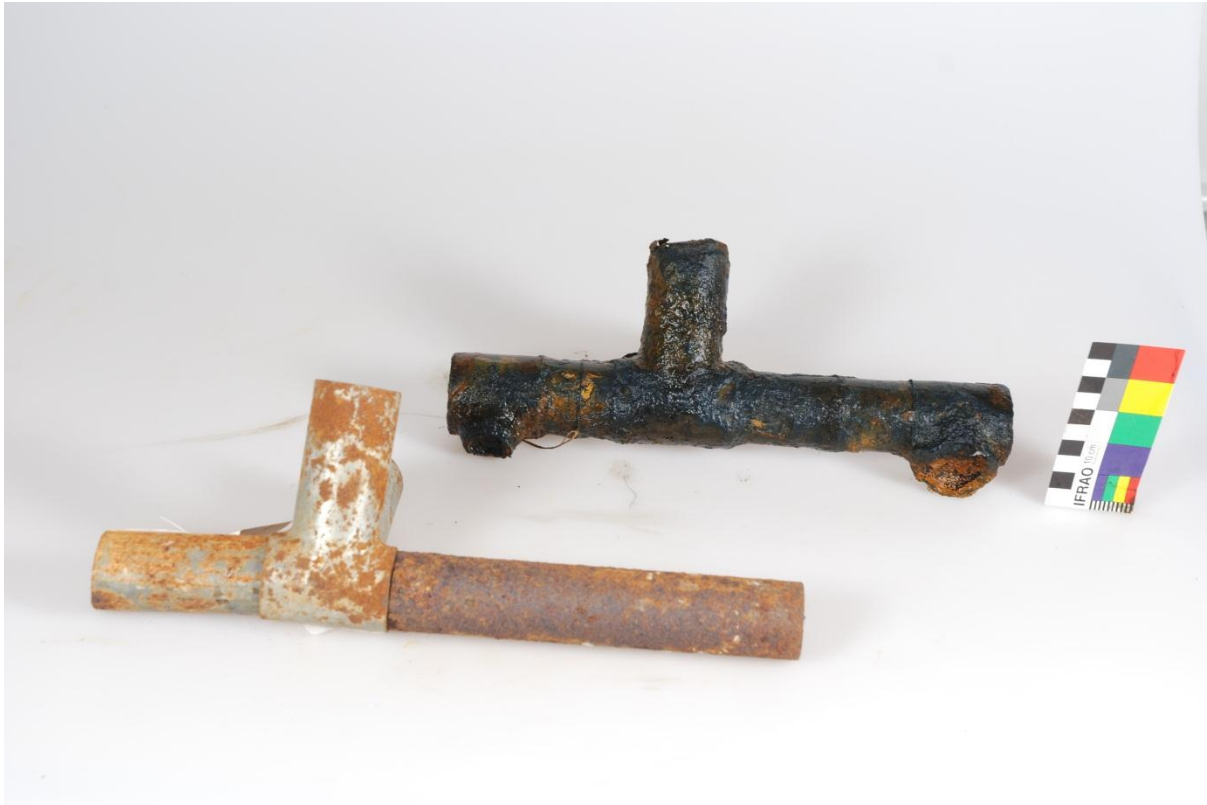
Fragment 4: Straight part from the top of the diamond-shaped section – this is most probably where the skid or rudder was attached. The two remnants of these attachments are seen at either end.

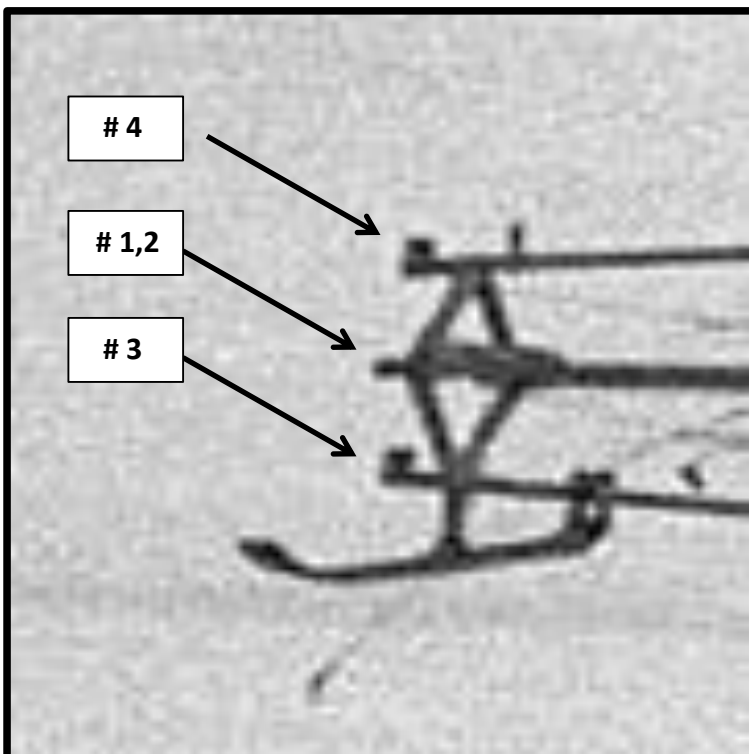
This is a blown up part of an image of the air tractor which clearly shows where the fragments found in the harbour came from. Numbers correspond to the above pictures.

These pieces are clearly from the final section of the airframe, and have been cut off. Perhaps it was part of an experiment to find the best way to control the air tractor, and, along with the ice skid, it was jettisoned in the harbour when it failed.

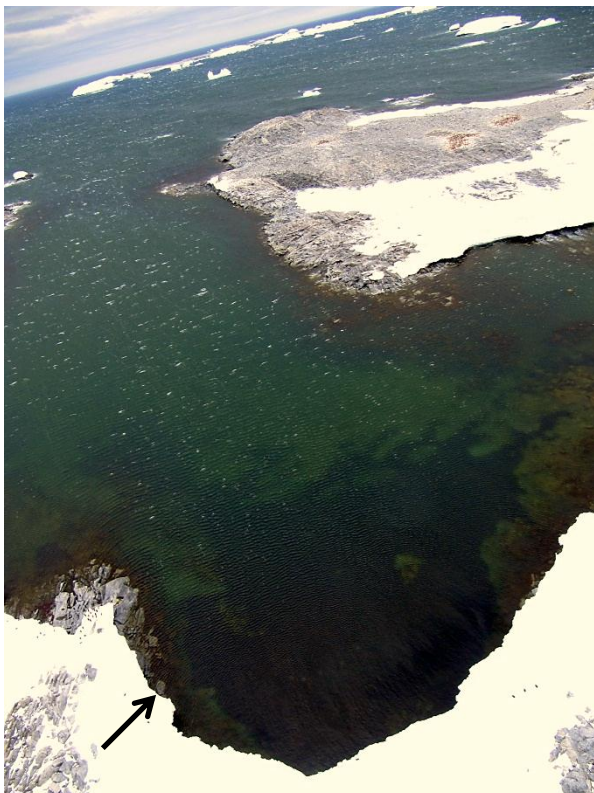
It can be seen from the photograph below that there is an area of seaweed – actually seaweed fragments about 200mm deep (dark area) – covering the bottom of the harbour at the Southern end. This could have concealed fragments.

A kite aerial photograph showing the bottom of Boat Harbour. The fragments were found at the bottom left (arrow). The underwater area around the fragments was thoroughly searched, including under the edge of the ice for about 50m in both directions and 30m from the edge, without finding anything else. It is possible that the seaweed debris (black area) concealed something of interest.

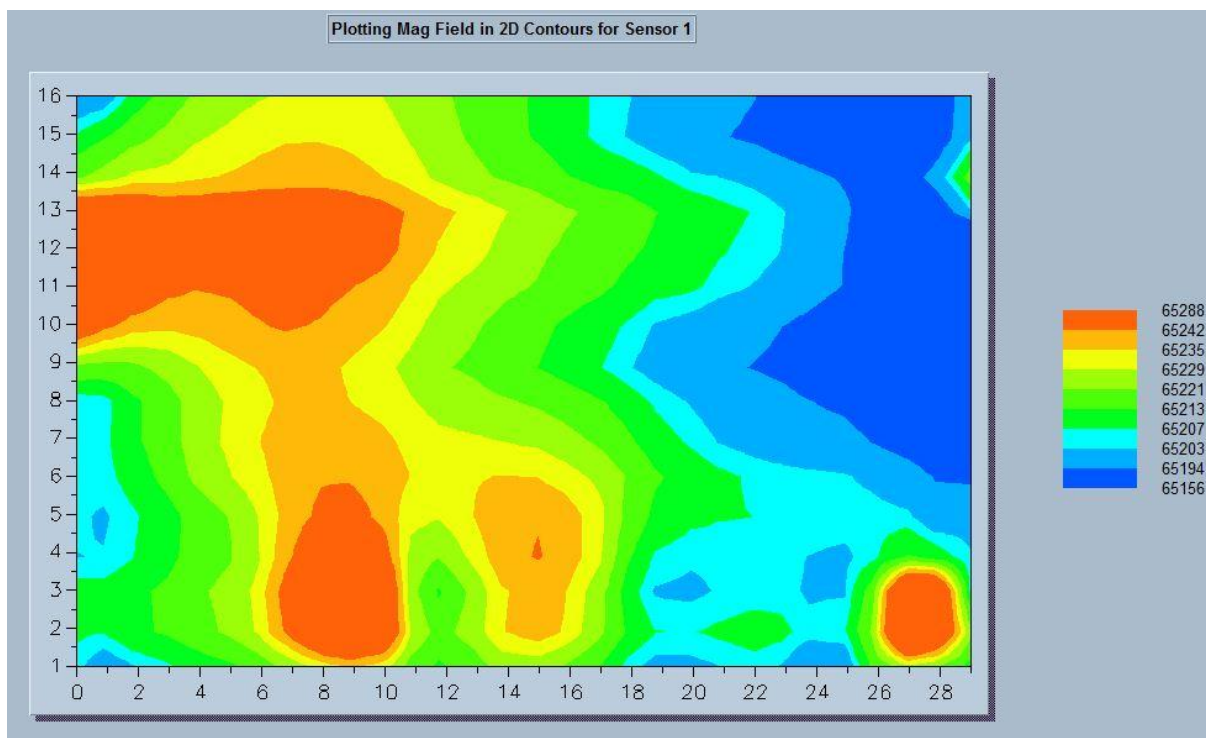
Magnetometer survey results plotted as a 2D map across the search area. The area where the airframe is thought to lie is shown by the red contour at 7,4. It is unclear whether the large red area at 4,12 is related to the underlying rock or ferrous artefacts. The localised area at 27,2 (right hand corner) is probably a case.

The results of the magnetic survey show a positive finding in the area where the air tractor is thought to lie, but also show a band running EW about 10m more northerly. No signals were found in this latter area using the metal detector, but it must be remembered that the metal detector had a very limited range. If the findings indicate metal, then the area would

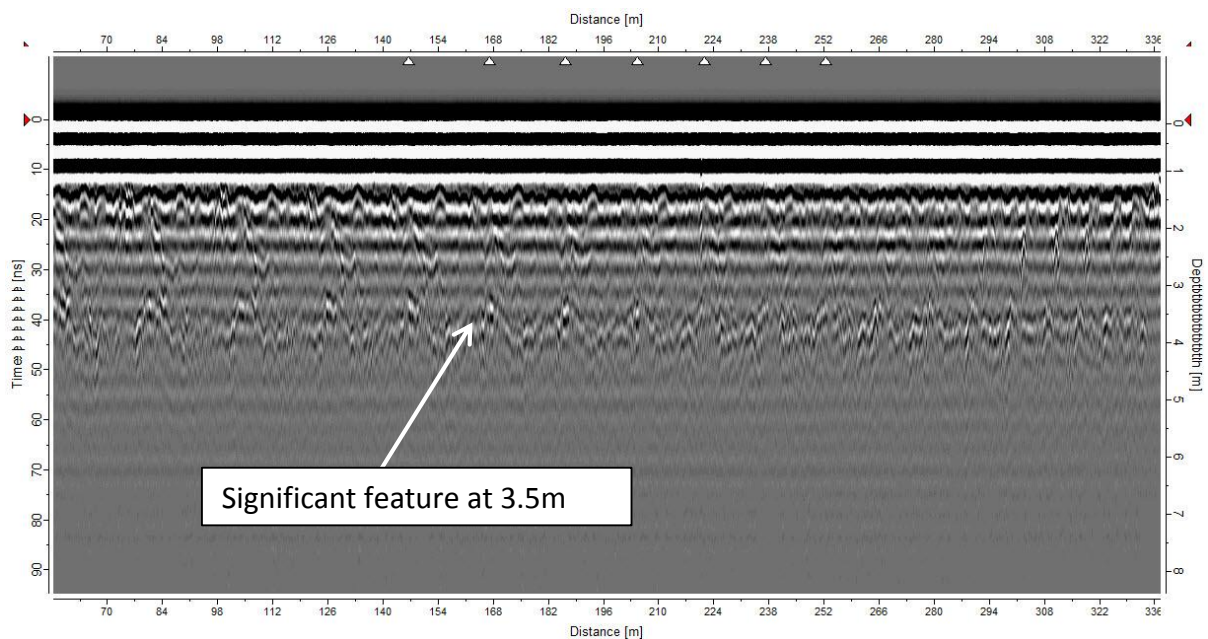
This is a radar trace from a spiral track from last years' GPR search. It appears that a significant feature lies at about 3.5m. It is visible in multiple echoes as the radar unit passes round the spiral.

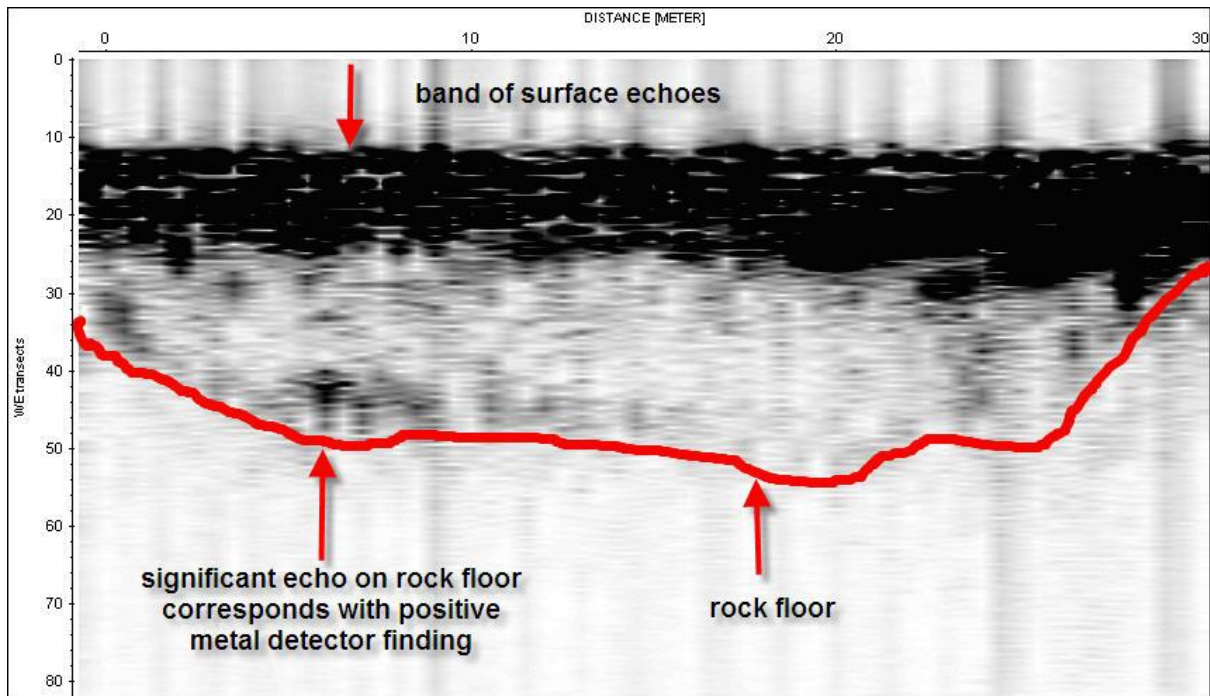
This is a linear trace through the area where the airframe is thought to lie (from photographic evidence). The rock floor can be seen across the 30m of the search area, and what appears to be a significant echo at 6-7m, which is roughly where the frame should lie, and corresponds to the area where the metal detector gave positive findings.

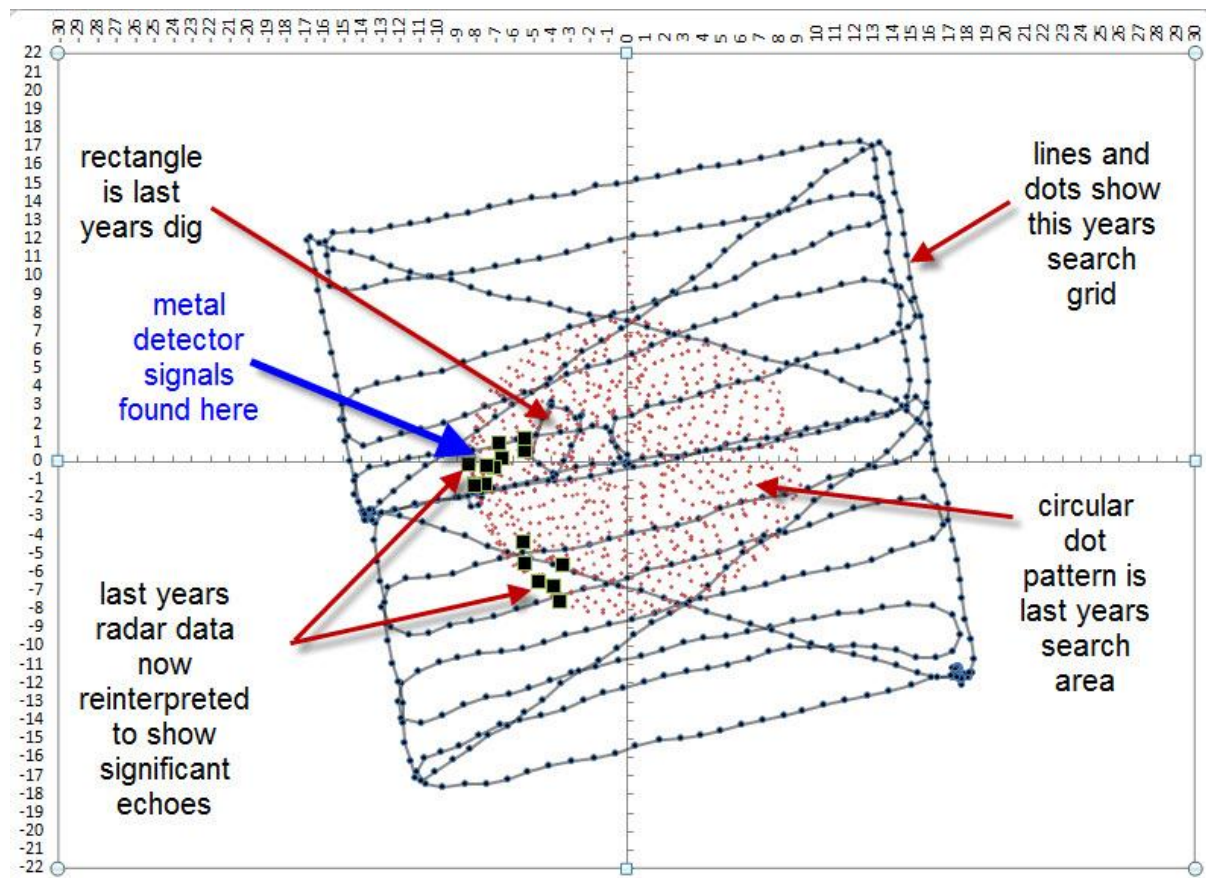
The grid pattern is shown by dotted lines (from DGPS survey). The dots show last years search pattern, and the positive metal detector signals are shown in relation to the grid and last years trench. The positive magnetometer data (not shown in this diagram) forms a band which passes through the trench and the area of positive signals.
