THE SEARCH FOR MAWSONS AIR TRACTOR

Dr Chris Henderson

SUMMARY

THE SEARCH FOR THE AIR TRACTOR AT CAPE DENISON

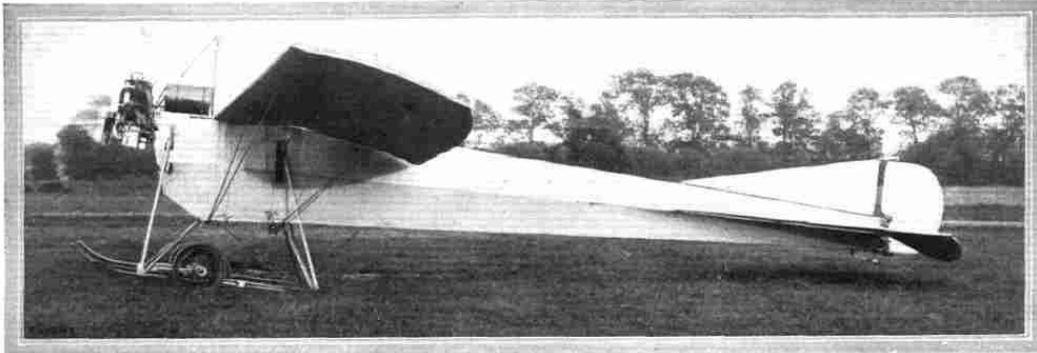
Figure 1 The Vickers plane used by Mawson. Note the ski attachments which proved essential on the ice.

The Vickers Monoplane.—Side view, showing the protruding engine and the manner in which the wing trusses are carried to the base of the fuselage. An idea of the wing cross section may also be gathered.

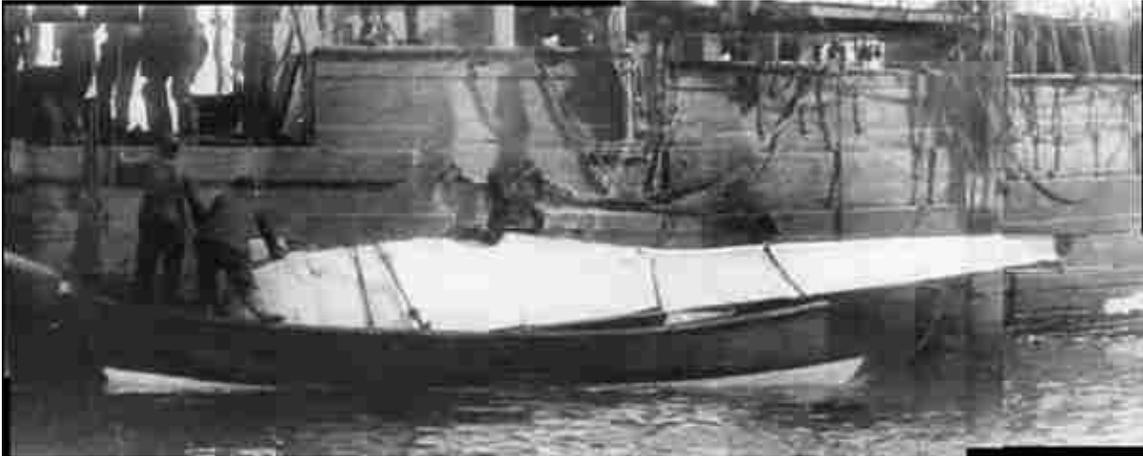
Figure 2: loading the airframe onto the Aurora in 1911

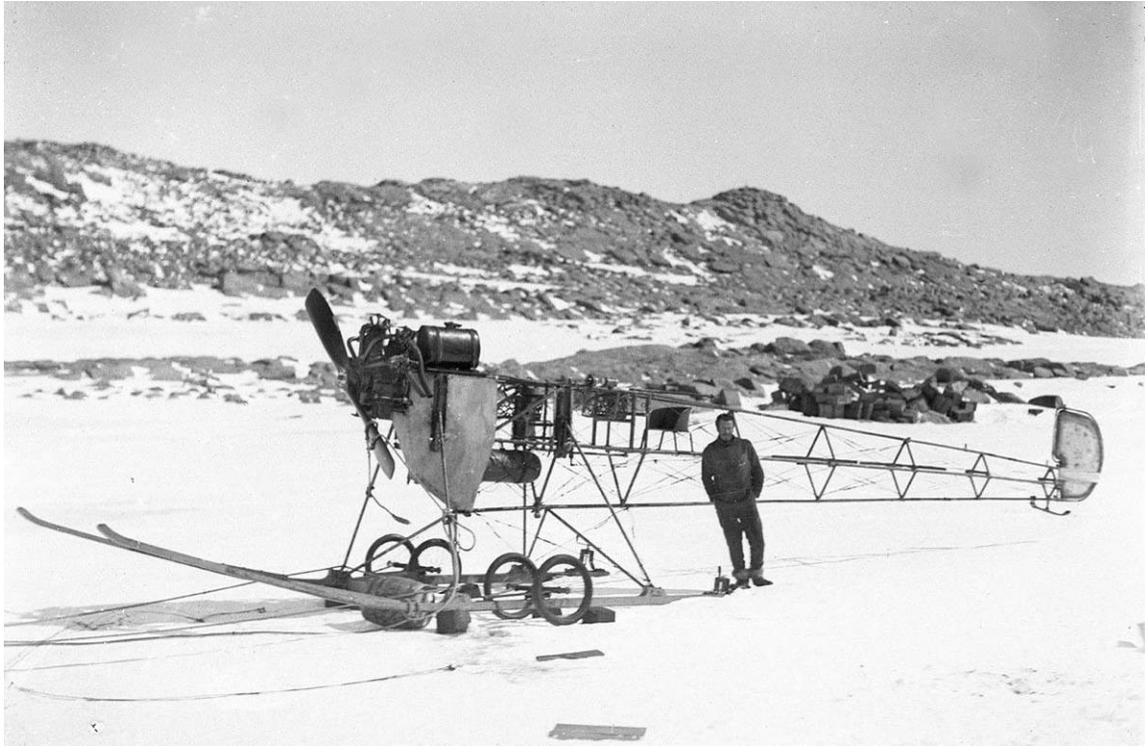
Figure 3: *Bickerton with the air tractor. Note third custom-built seat which was cut from the frame, and recently found at Cape Denison among the rocks across the harbour. The frame is at least 2.5m tall.*

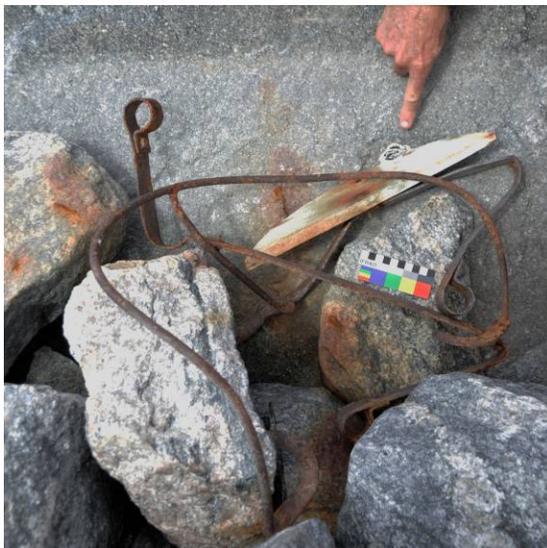
Remains of air tractor seat found and catalogued in 2008 by Anne McConnell. The seat was found on the northeastern edge of Boat Harbour about 200m from the frame. Note the remnant of canvas on the back of the wooden platform. (Photo David London).

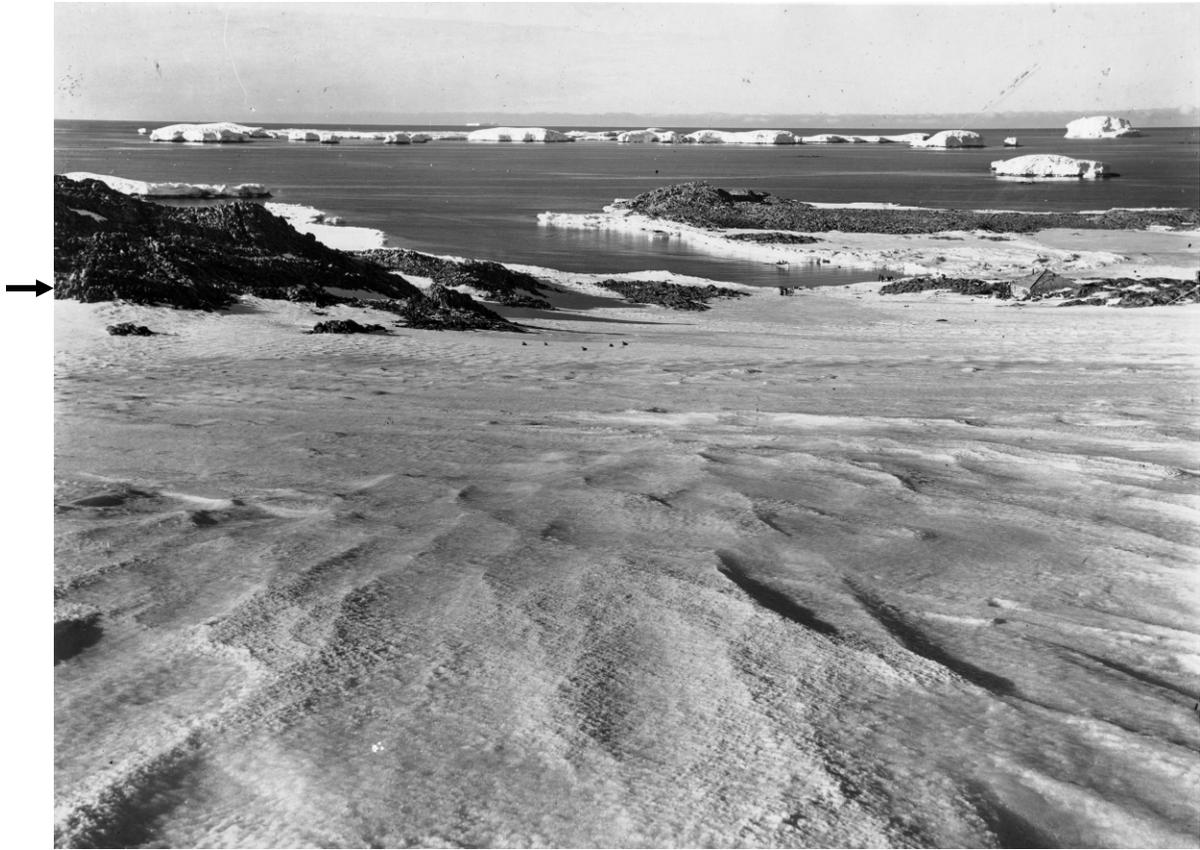
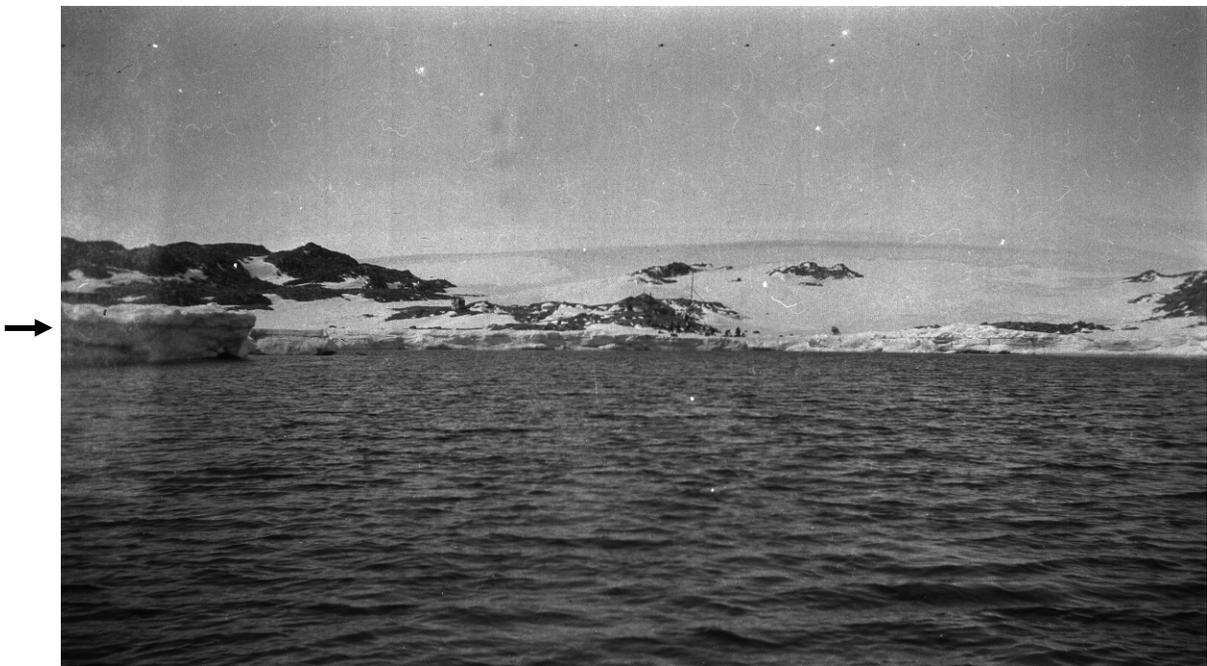
Figure 5 Pictures of Mawsons Huts and valley 1931 by Eric Douglas from South (top) and North (bottom). The Ar Tractor frame can be seen near the harbour in the top image, and as a small dot under the right edge of the double rock outcrop to the right of mid-photo of the bottom one. (Photos from Sally Douglas collection)

The following two pages show the valley at Boat Harbour with the air tractor in 1931. The pictures are all from the collection of Sally Douglas, Eric Douglas’ daughter. They clearly show the position of the frame and the level of the ice at the time of the visit.

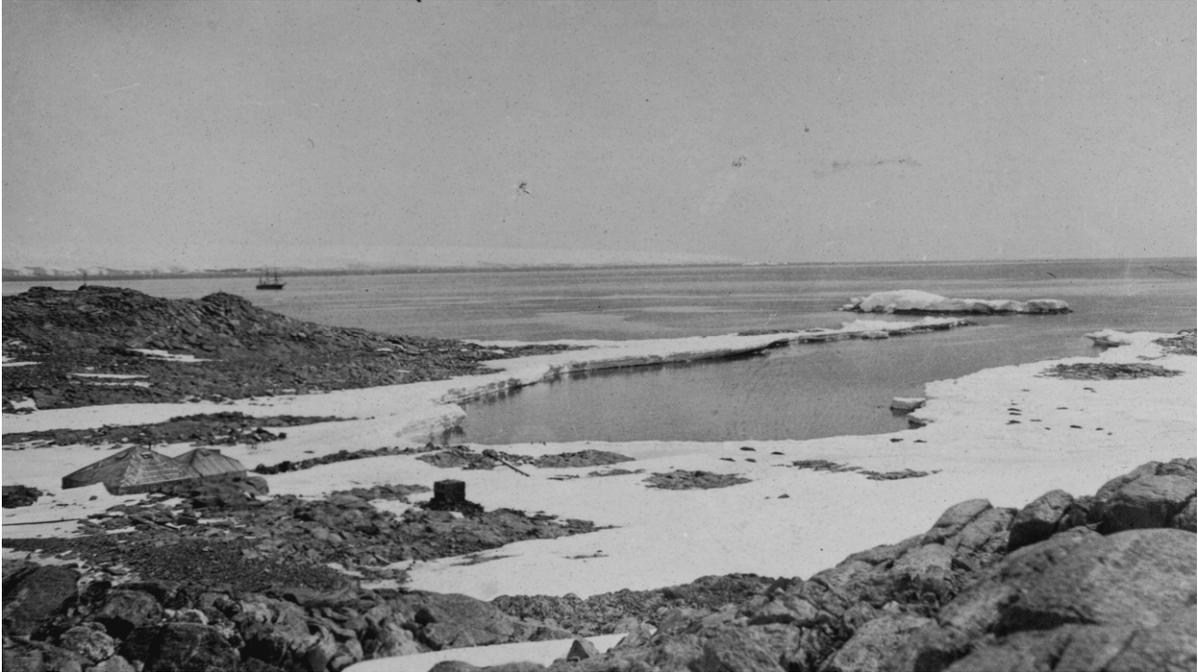
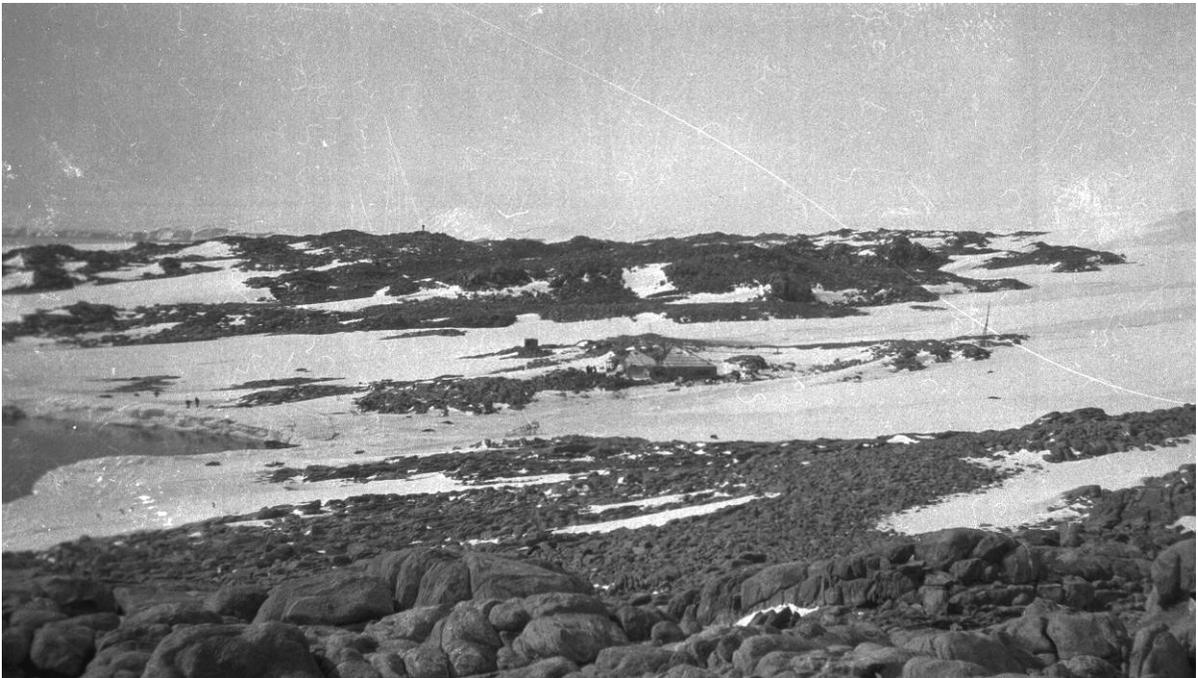
Figure 6 Pictures of Mawsons Huts and valley 1931 by Eric Douglas from East (top) and West (bottom). The Air Tractor can be seen just above the front of the hut in the top image, and in line with the transit hut in the bottom image. (Photos from Sally Douglas collection).

Figure 9: taken from 1931 and from 1976 – the photographs are taken from points almost exactly opposite each other (the air tractor frame in 1931 is shown by an arrow). No movement of the frame is seen in 45 years, supporting the proposition that the ice is not glacial in this area. Comparing the 1976 picture with the 1912 picture in figure 6 shows there has been no movement in 64 years.

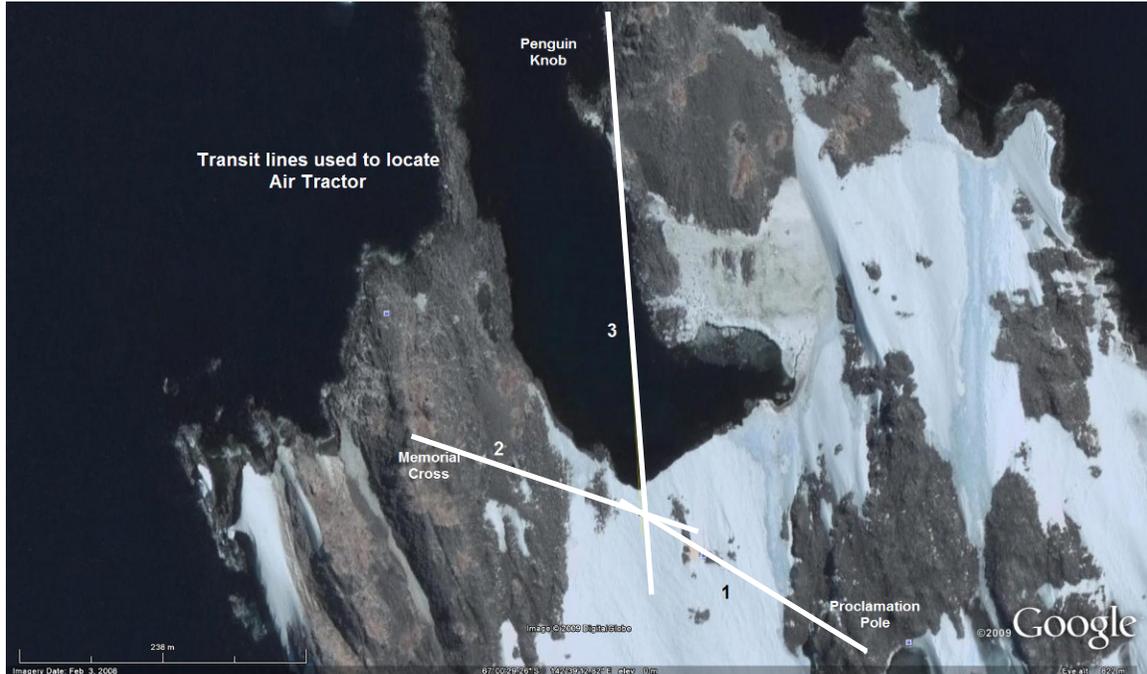
Figure 7 : *Google earth picture of Cape Denison showing the three transit lines (white)) derived from a study of images from 1931 and 1976. The lines were used to pinpoint the position of the air tractor frame.*

The three transits were tested on the ground and found to be very sensitive to translation, well separated from each other, and readily identifiable. They were therefore considered to be reliable indicators of the position of the air tractor frame. Given that it was known (see appropriate section below) that the ice did not move in the area (ie it is not glacial ice) then the position was accepted with confidence. This position is vital to all search efforts. A description of the three transits follows:

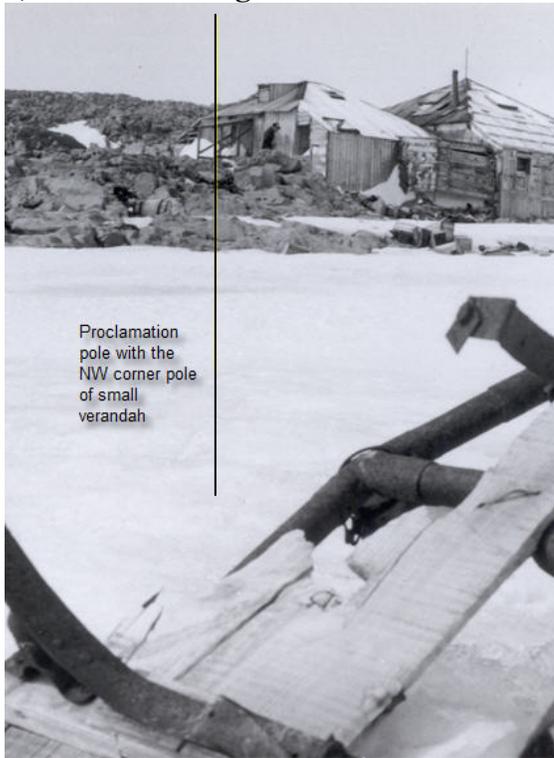
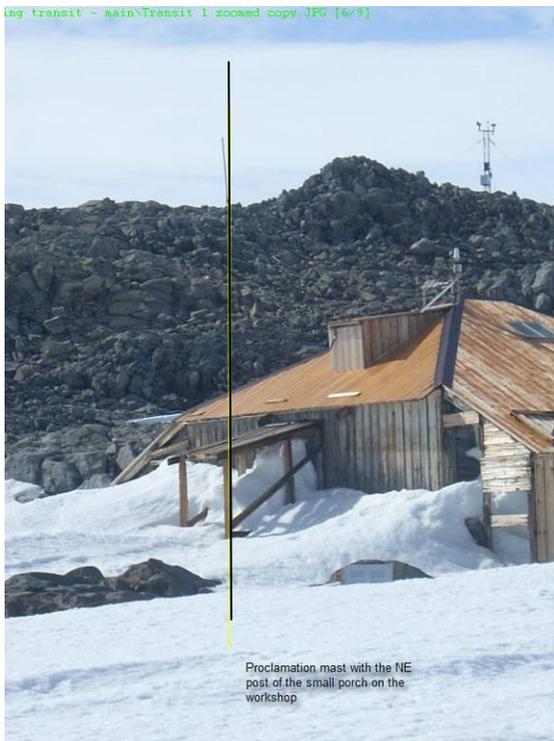
1) transit looking East

This transit is derived from the 1976 picture by Bob Reeves. It shows the frame about 500 mm out of the ice, and the transit points are the Proclamation Pole on the hill, and the NW corner post of the small porch on the workshop of Mawsons Hut.

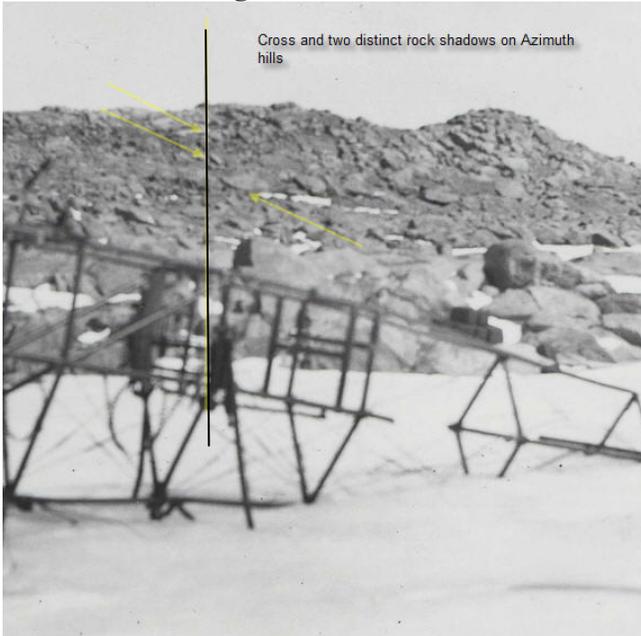
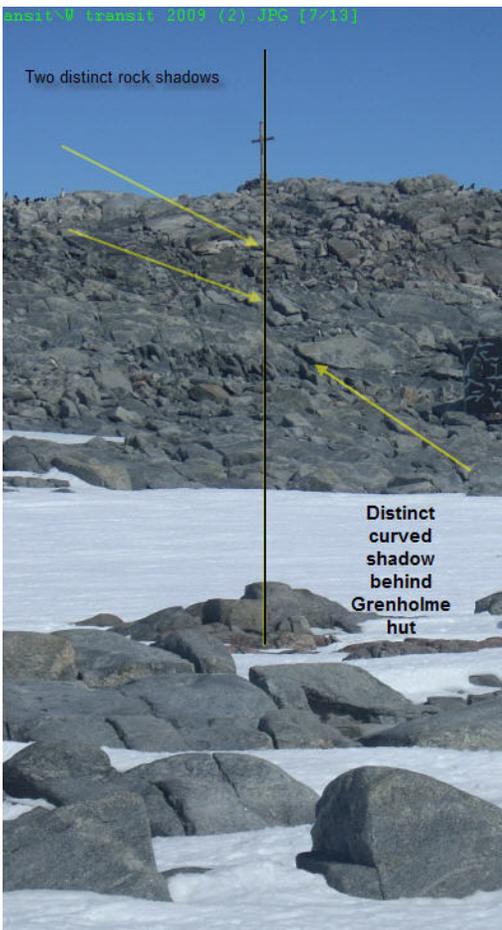
2) transit looking West

This picture is taken from the 1931 expedition by S Campbell. The rock shadows provide the transit in conjunction with the Memorial Cross – it is necessary to see the rock face in sunshine at about 1pm to match the original photo.

The transit points are the Memorial Cross, and two distinct rock shadows on the hillside. The curved shadow behind Granholme hut provides a good orienting feature.

The triangular rock at the bottom right of the picture is an obvious feature which appears on other photographs, and proves useful to orient the view.

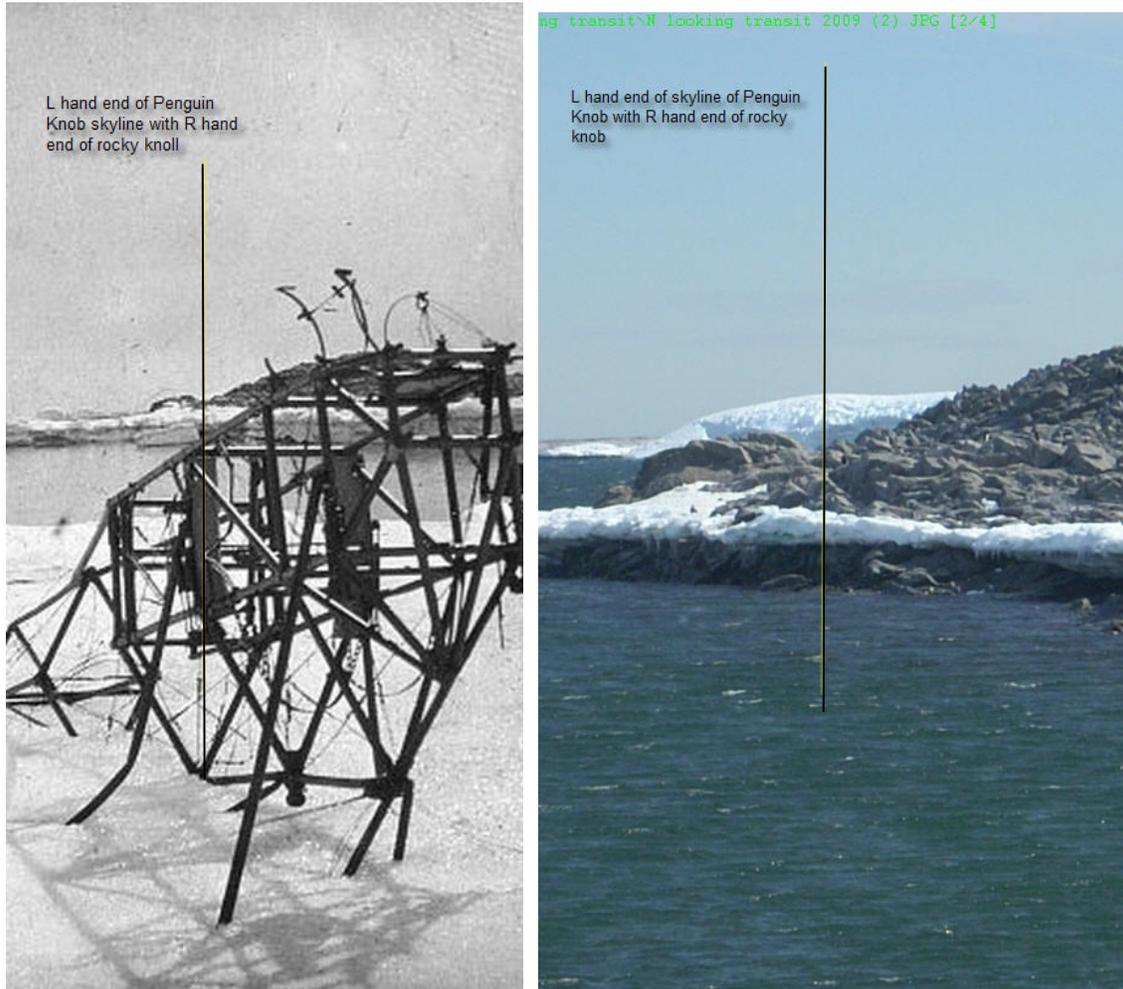
3) transit looking North

This picture is from 1931. The rocky knob is about 100m in front of Penguin knob, and the transit line is quite easy to see, though it looks hard in the picture.

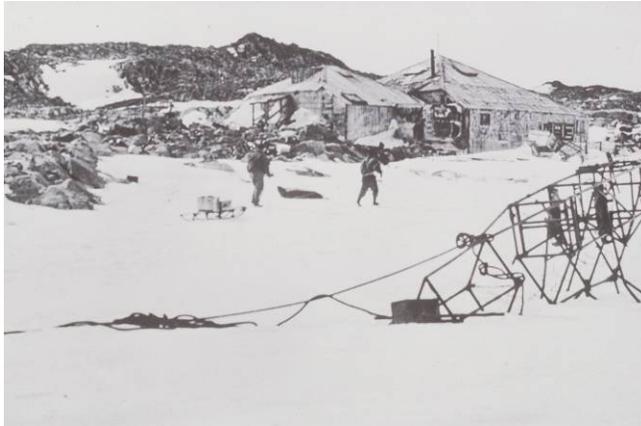
Figure 8: the airframe in 1912 This photograph is taken from a few metres north of the place in the 1976 image below. Moving the camera into the 1976 position would give exactly the same transit as the 1976 picture. The frame is already partly buried in the ice. [Note that the third seat has been cut from the frame, which establishes that its 2008 discovery on rocks across the harbour is not related to the position of the tractor.]

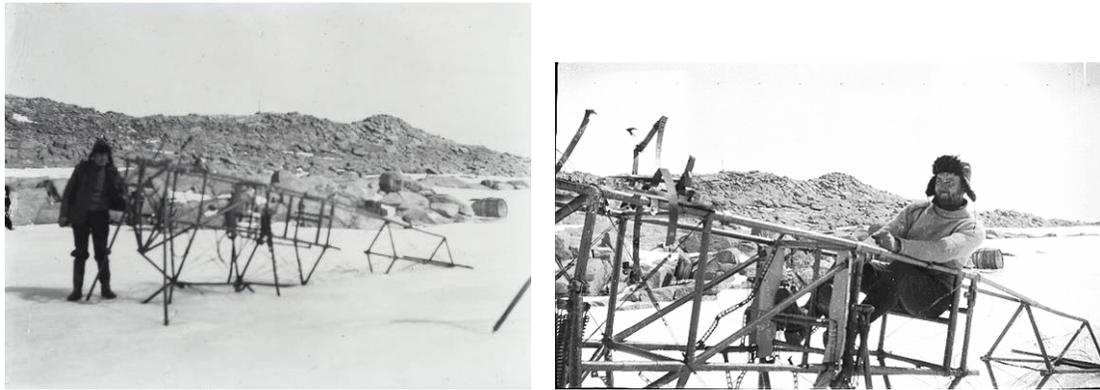
Figure 10: from BANZARE 1931: indication of the amount of metal in the airframe. Pilot Eric Douglas is seen sitting in the frame in the right hand picture, on the left an unknown man (possibly Frank Hurley) gives scale to the frame. (Photo Sally Douglas collection)

Ground Penetrating Radar is particularly sensitive to metal objects. Two aerials were used - 250Mhz and 500Mhz. These have an effective depth of about 4m and 5m in ice, and a resolution of 45 cm and 25cm respectively. A thin rod sideways to the aerial would not be seen, but lengthways it would. The air tractor frame is made of steel tube about 40mm x 1.5mm. Individual tubes would be too small to be seen when crossing the beam, but the whole frame is made of tubes and metal straps oriented in many different directions. It is 6m long, and it is unlikely that either aerial would miss the aggregate mass of metal.

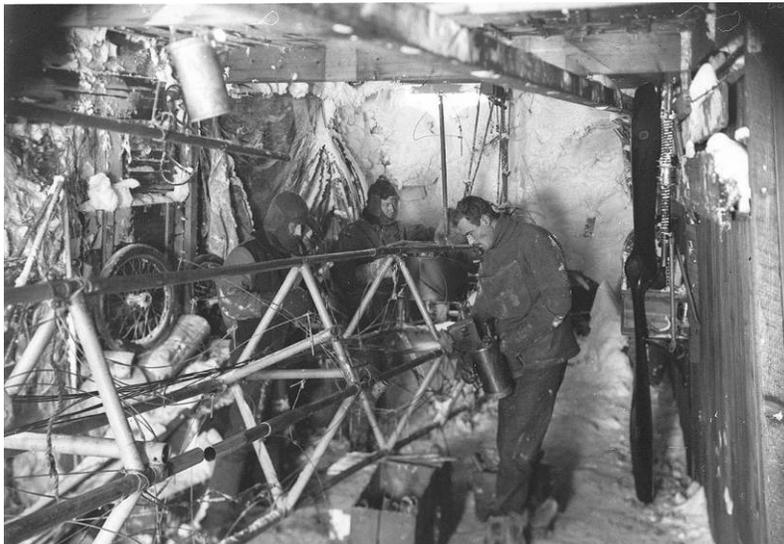
Figure 11: the amount of metal in the frame should make it visible to radar using either the 250Mhz or 500Mhz aerial. The lower picture shows Bickerton at work on the frame in the 'aircraft hangar' on the west side of the main room of the hut.

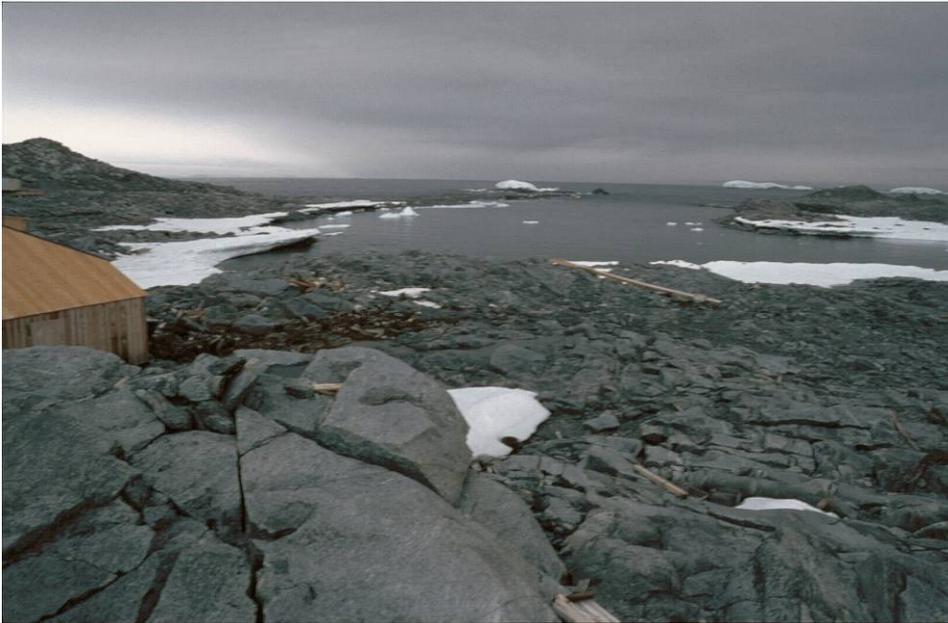
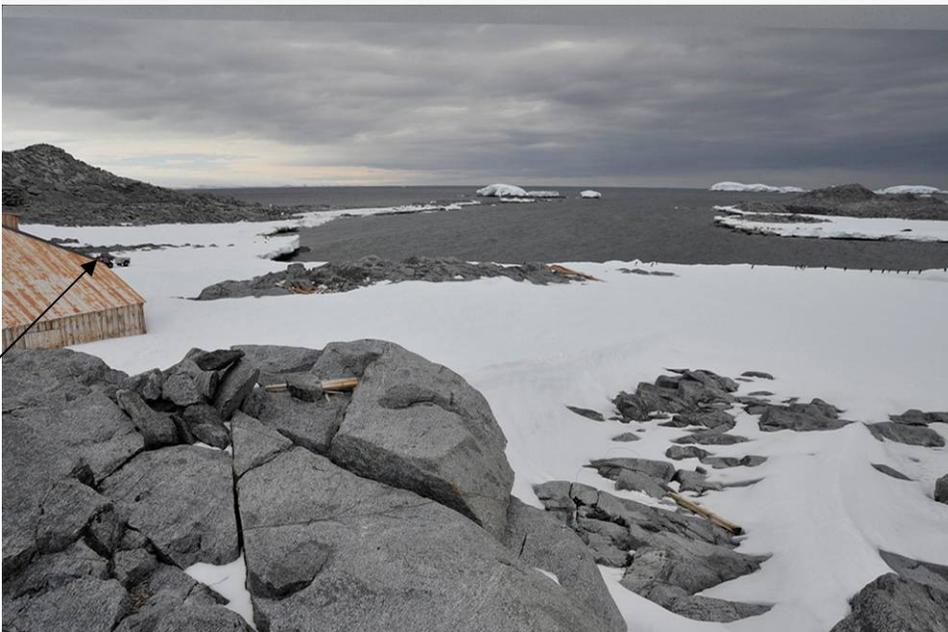
2002 from SE of the hut, showing Boat Harbour (Photo:Ian Godfrey)

Figure 12: *Extensive exposed rock is seen in 2002 (top). The air tractor frame position is represented by the quad bike and trailer seen in the lower image above the hut roof (arrowed). It can be seen that the frame would have been close to the edge of the harbour in a melt. (Photo:David London).*

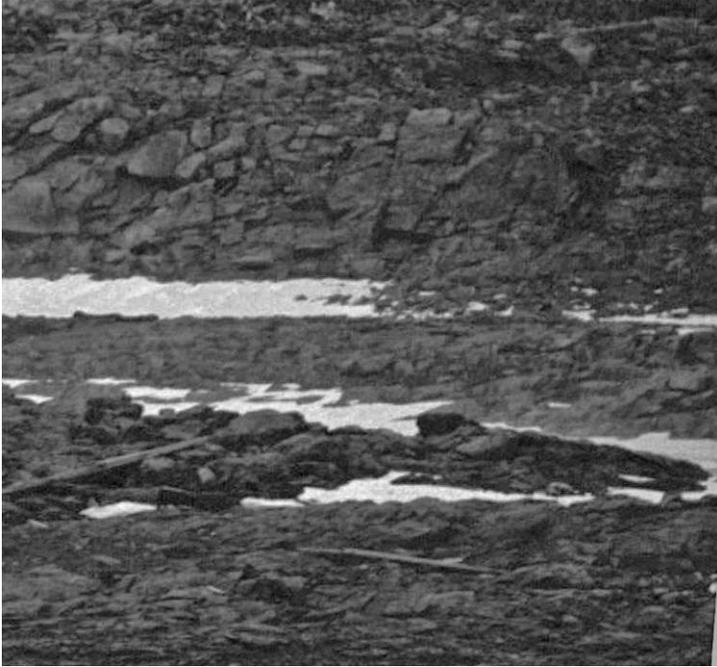
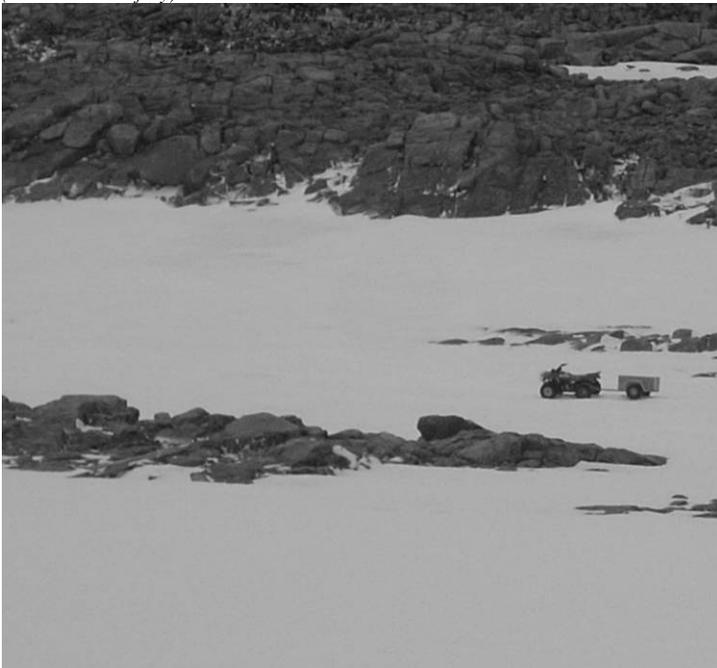
Figure 13: Facing Memorial Hill. The depth of snow cover was estimated by measuring the prominent rock in the middle of the picture, and is about 1m higher in 2008 (lower picture). The quad bike and cart represent the place where the air tractor was estimated to have been. (Photo:David London).

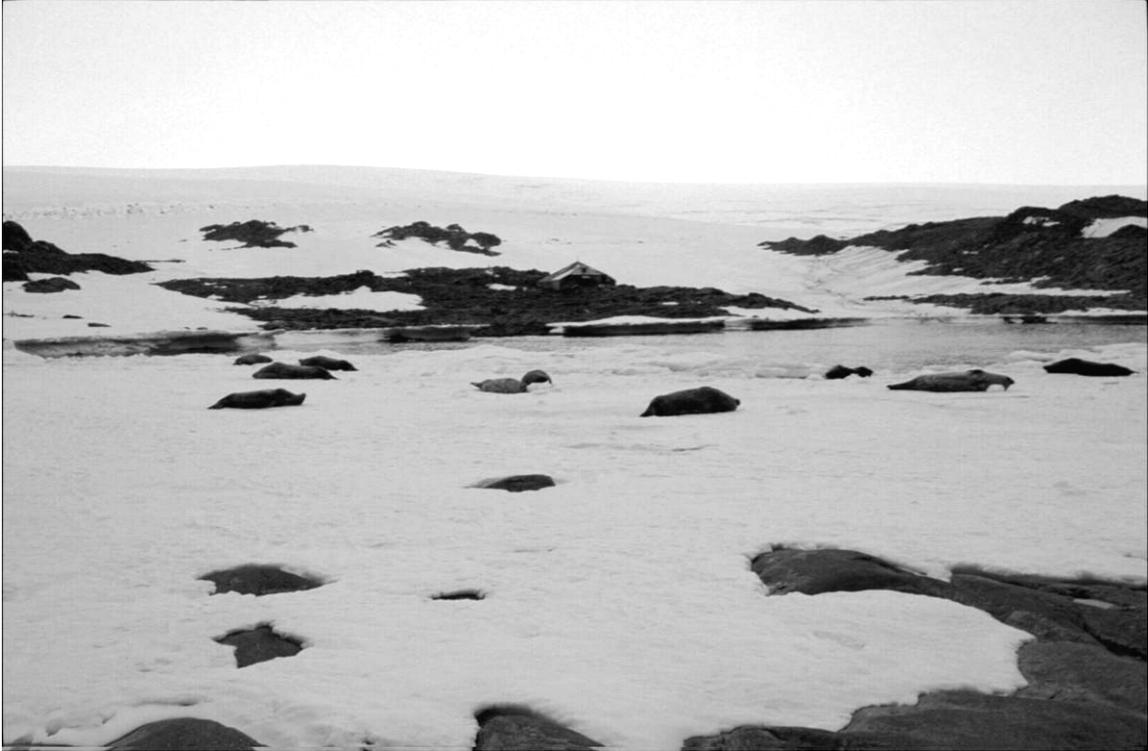
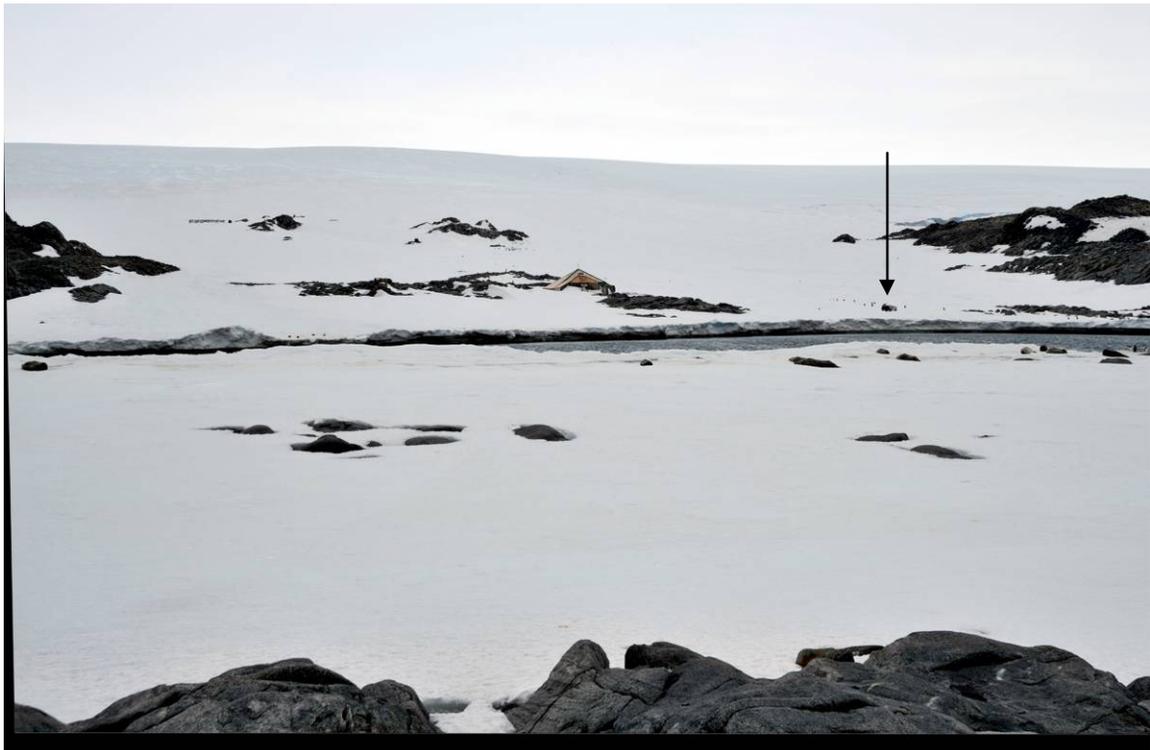
Figure 14: Facing S across Boat Harbour. The air tractor position is arrowed and can be seen to sit almost over the 2002 glacial melt stream. Note exposed rocks in upper picture (2002). Compare the level of snow 2002 with 2008 (bottom). (Photo:David London).

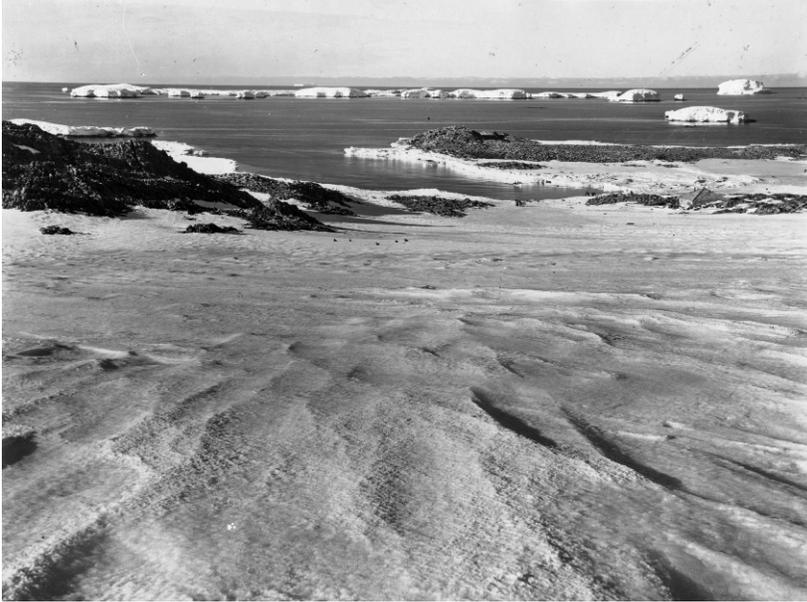
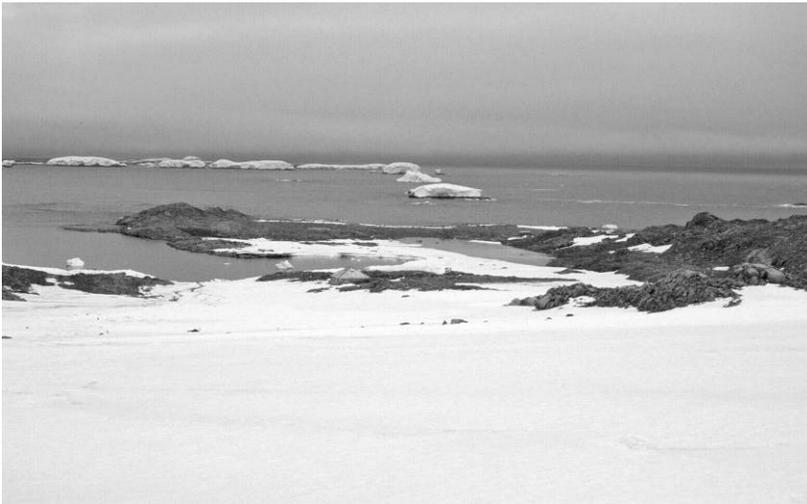
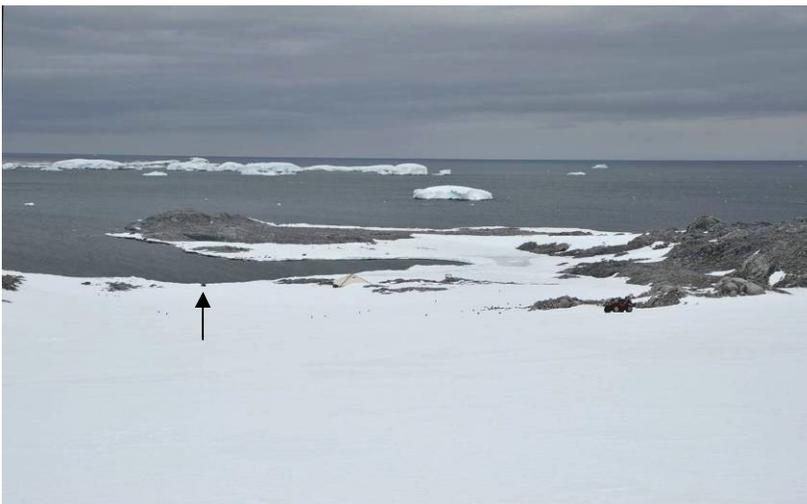
Figure 15: *If the air tractor had sunk in the ice, and was still there, where would it be? This is a general view of the bay seen facing N from the hill behind the huts. The images are from 3 different years. The air tractor is seen in the upper picture (1931) and the quad bike (arrow) in the lower one (2009). The middle picture is from 2002. The ice level in 2002 is about the same as in 1931, and about 1m lower than 2009. The frame is about 2.5m high.*

A magnified image of the air tractor in the top picture shows that it had already sunk about 1m down in the ice by 1931. By 2002 it was not visible. Therefore the top of the frame would be at least 1m below the 2009 surface, and the bottom about 3.5m below it.

We found a radar anomaly at 2.5m, and dug down to the sea level at 2.7m but found no frame.

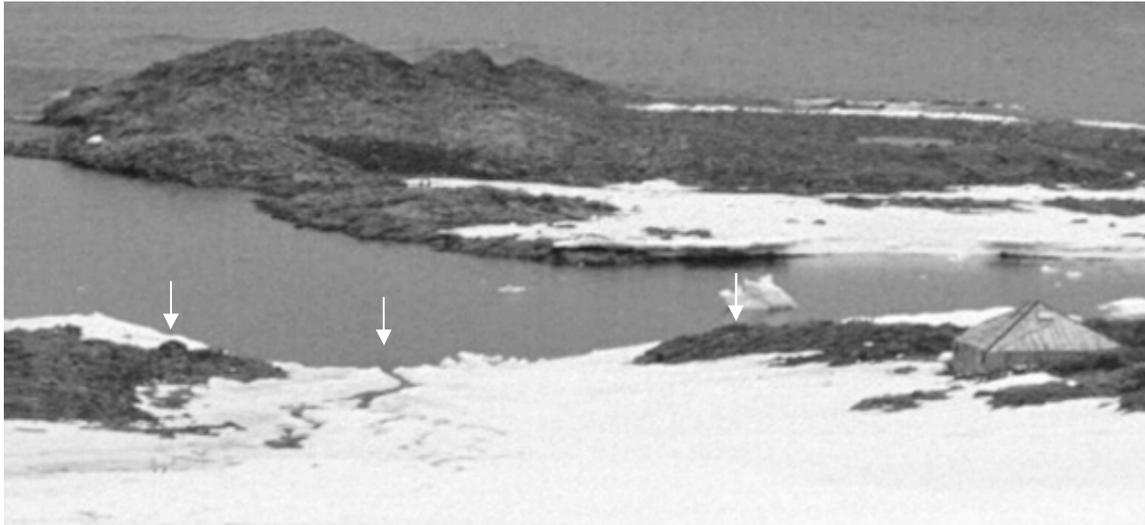
This is a picture of the important area from the 2002 image (above) showing the melt stream. Note the prominent rocks on either side of the stream (all arrowed) which are used to determine the position of the frame using the 1931 picture below. The frame was in the melt stream, suggesting that a larger melt creek would have directly affected the frame. (Photo:Ian Godfrey)

The position of the air tractor relative to the melt stream is important, as will be seen later, in making an estimate of its present position. It is likely that the ice melted around the frame sometime after 1976. If the frame was sitting more or less in what would have been a substantial watercourse, and this in turn fed into a channel in the rocks, then it is probable that it was washed, or fell, into the channel – where it remains now.

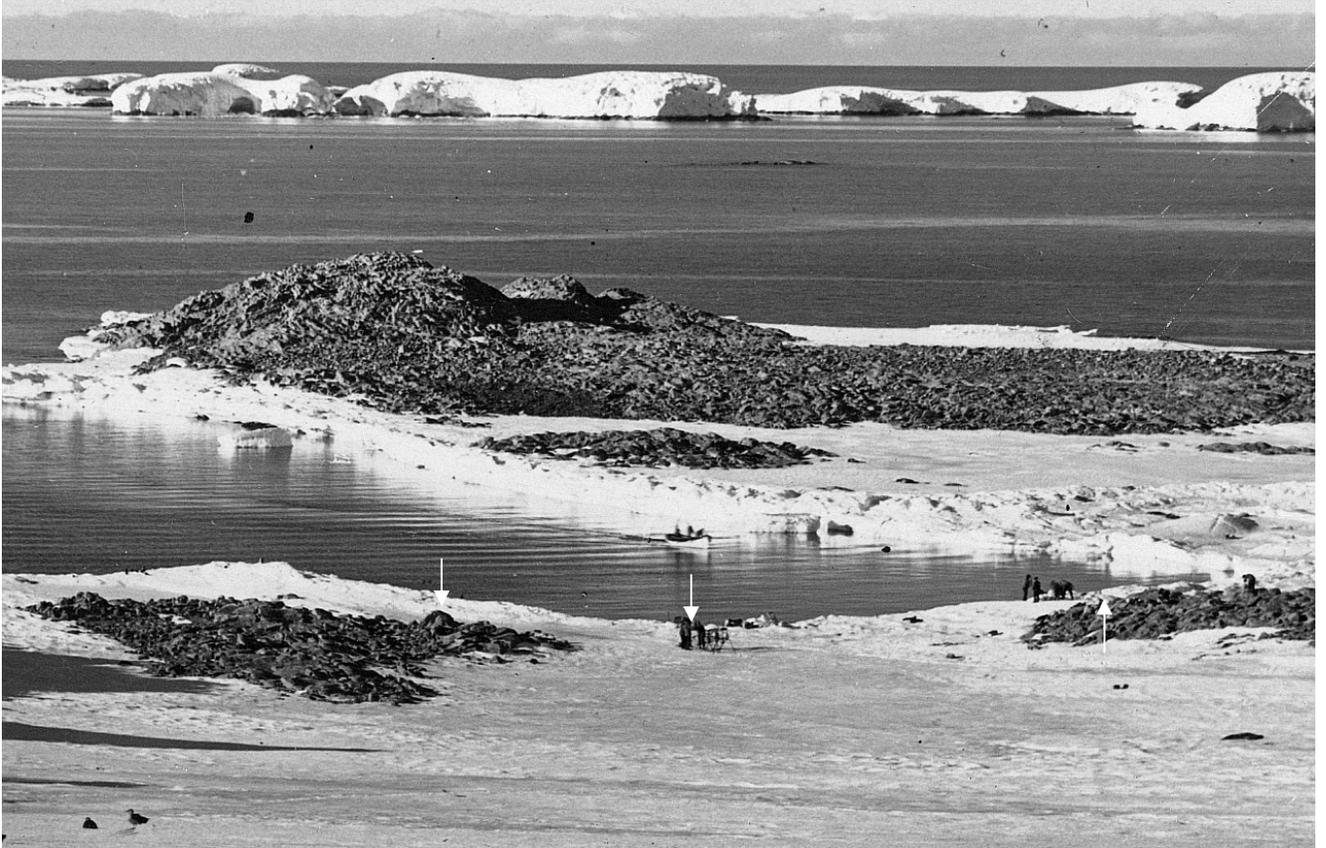
Figure 16 *This picture from 1931 clearly shows the air tractor near the edge of Boat Harbour (photo Sally Douglas collection)*

Three pictures, all taken from the hill toward the South allow a precise placement of the air tractor. A picture taken in 1931 by Eric Douglas of the frame and the harbour (below) is compared with Ian Godfrey's 2002 picture of the snowmelt (above), and this year's picture of the transit-line cross (below). The exact place from which the pictures were taken varies, as does the focal length of the camera lens so it is not possible to directly superimpose the images as has been done above. However, prominent rocks can be identified in all three pictures. These rocks are in line with the Air Tractor, and thus at the same focal distance from the lens. These points can therefore be used to define a proportional scale which is used to compare the images, and thus to place the tractor relative to the stream.

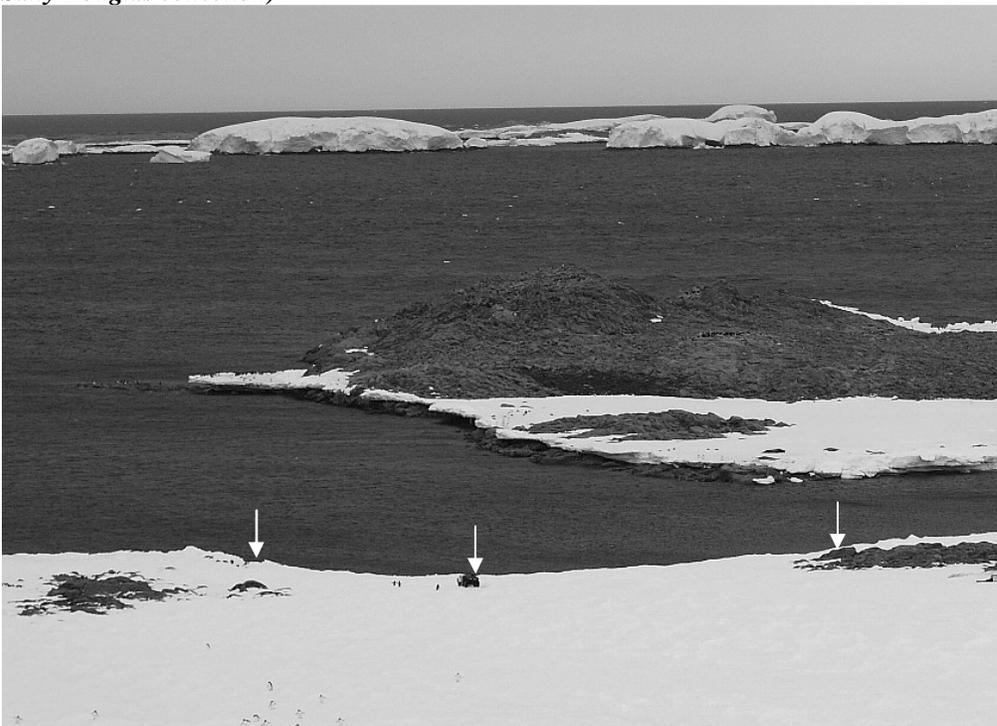
Figure 17 *Picture taken this year showing level of ice, identifiable rocks in the same focal plane, and the air tractor position represented by the quad bike.*
