THE SEARCH FOR MAWSONS AIR TRACTOR

UPDATE JULY 2009

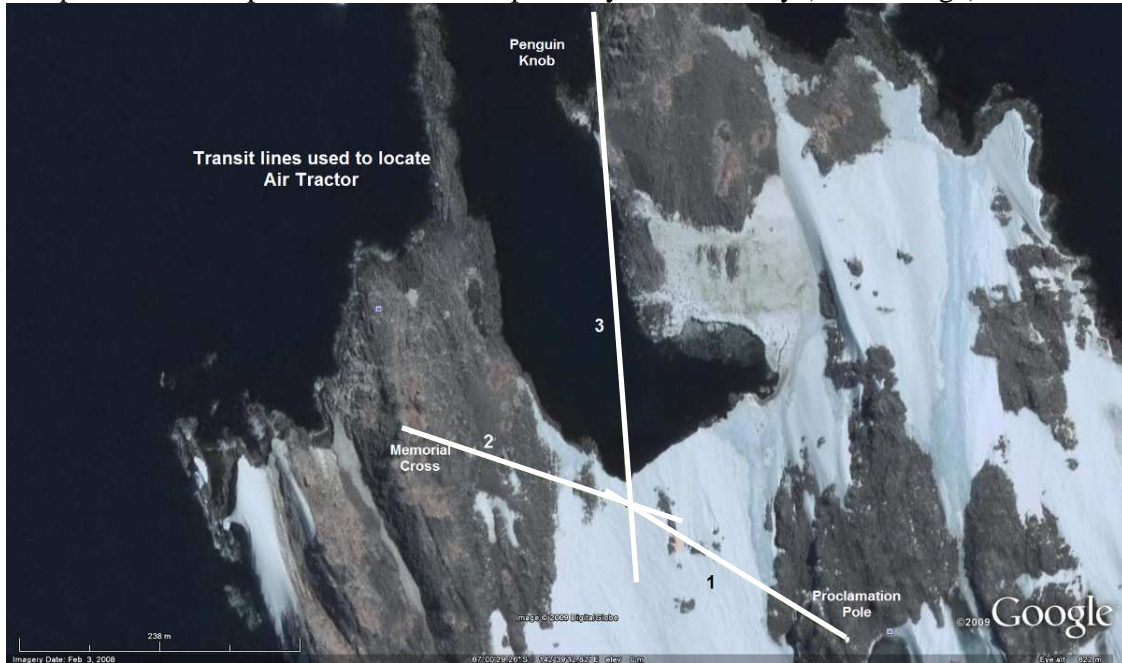
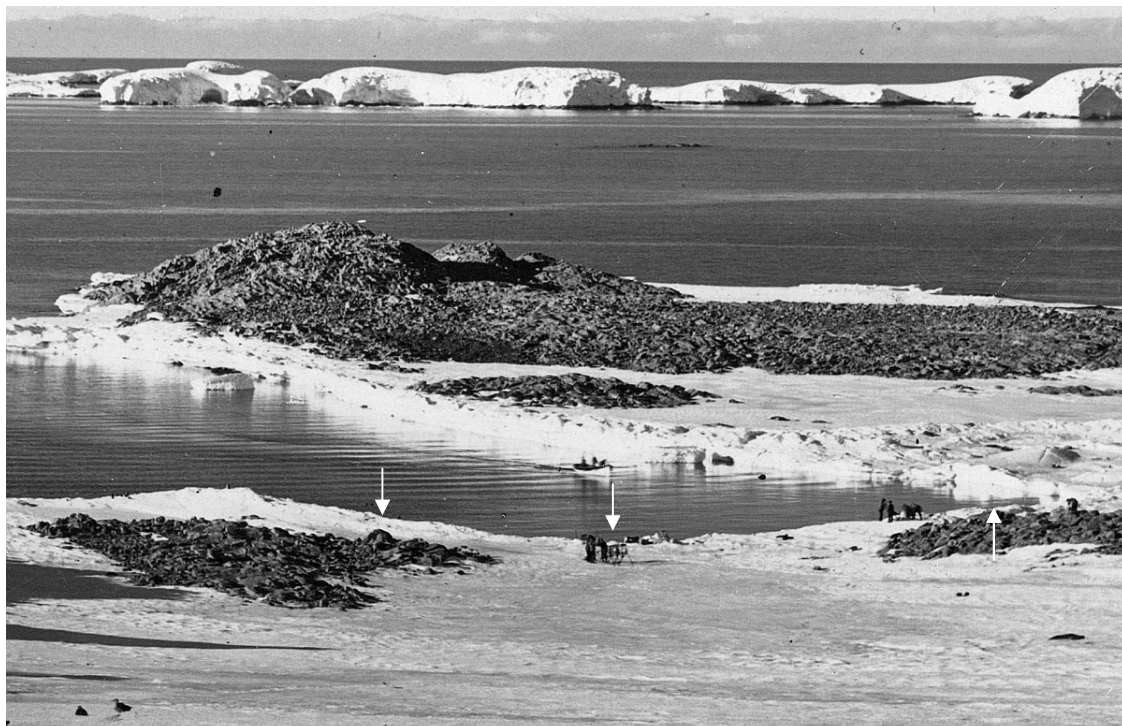
The following two images show the position derived from transits (top image) and a comparison of that position with a 1931 photo by Frank Hurley (lower image).

The photo confirms the position of the frame in the NS direction (central white arrow).

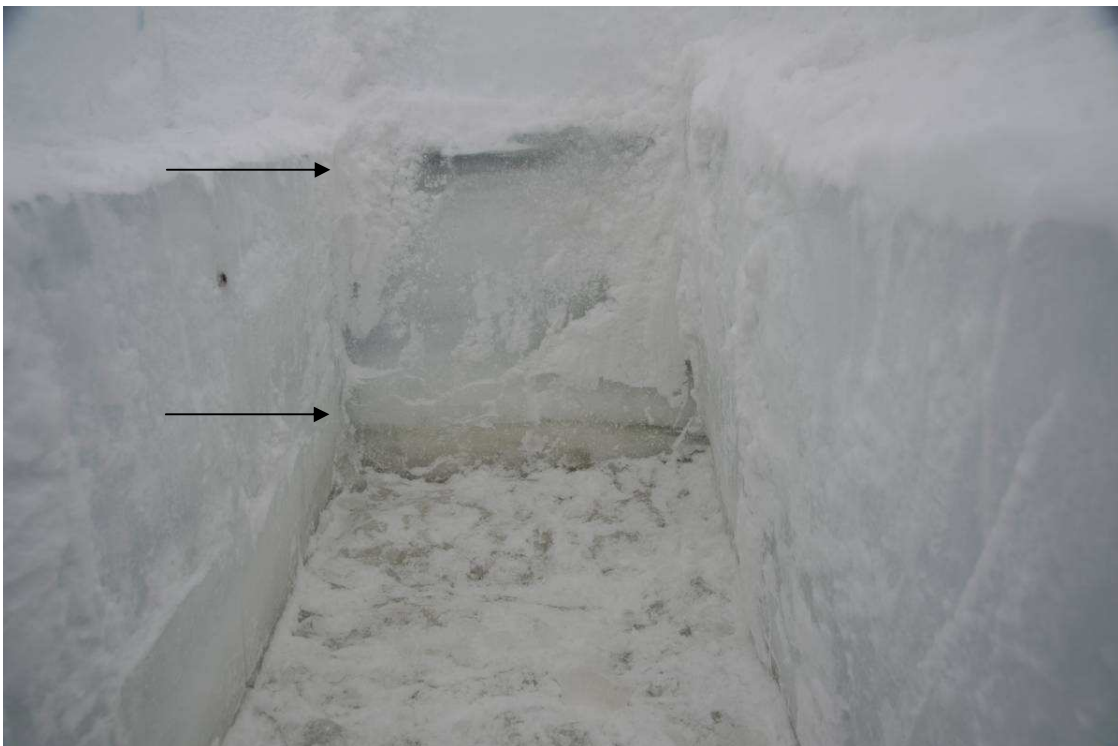
This picture shows the layer of hard blue ice found at the bottom of the trench (between the arrows). The depth of the bottom of the trench corresponds to the high water survey mark in the harbour.

The hard ice implies that the temperature rose sufficient to melt the ice down to 2m. Evidence from temperature records was sought to confirm this finding.

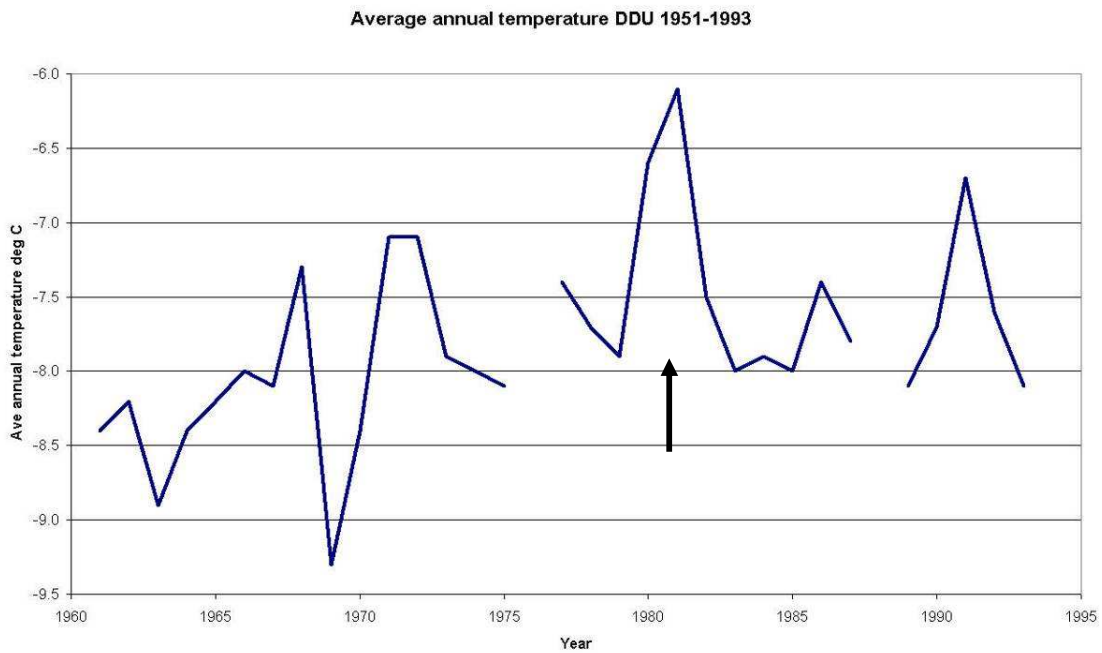
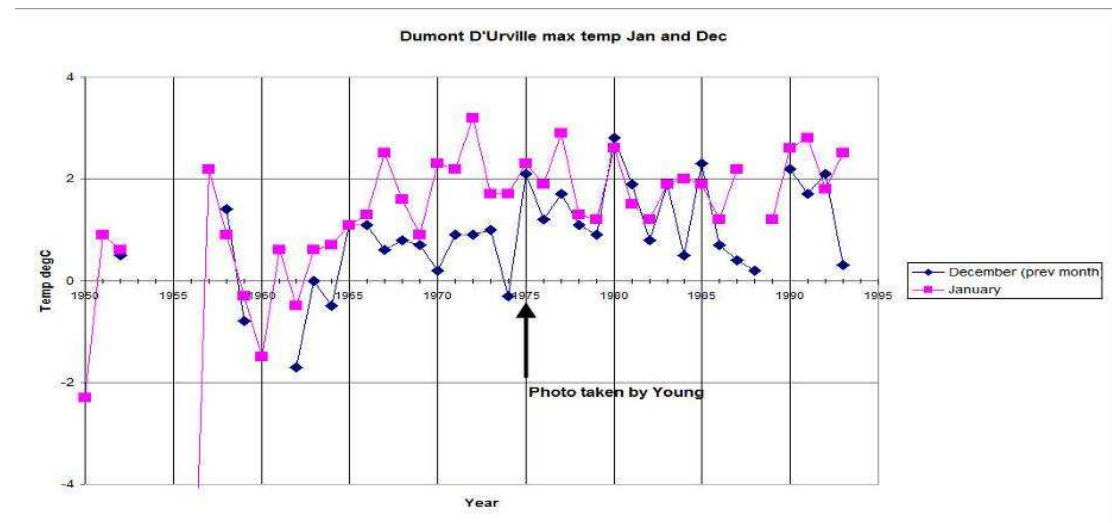
Temperature records from D'Umont Durville station indicated a rise in temperature around 1980. Monthly temperatures in 1977 and 1980 indicate that substantial melting occurred (lower graph).

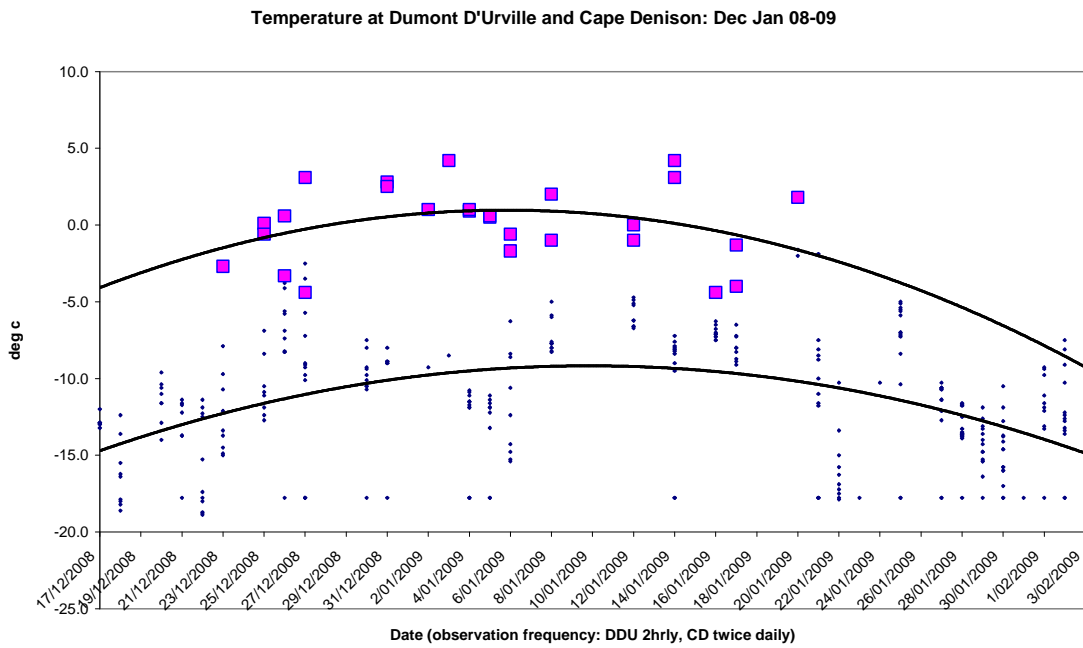
The summer temperature at Cape Denison is 5-10 deg higher than DDU as shown by last years data:

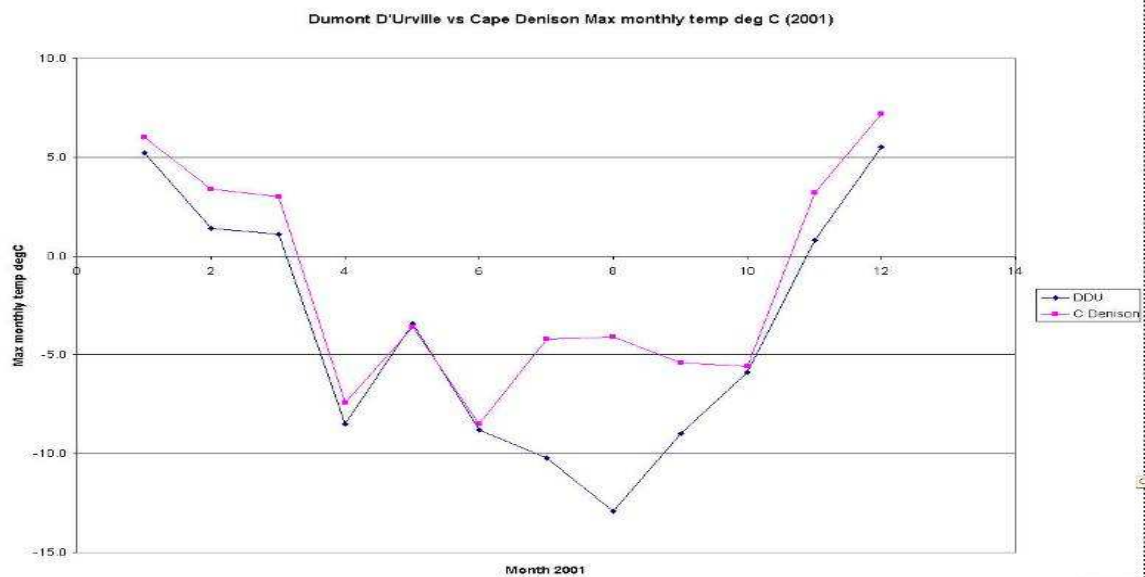
Based on 2001 data (see below), this temperature difference is likely to have been present in previous years.

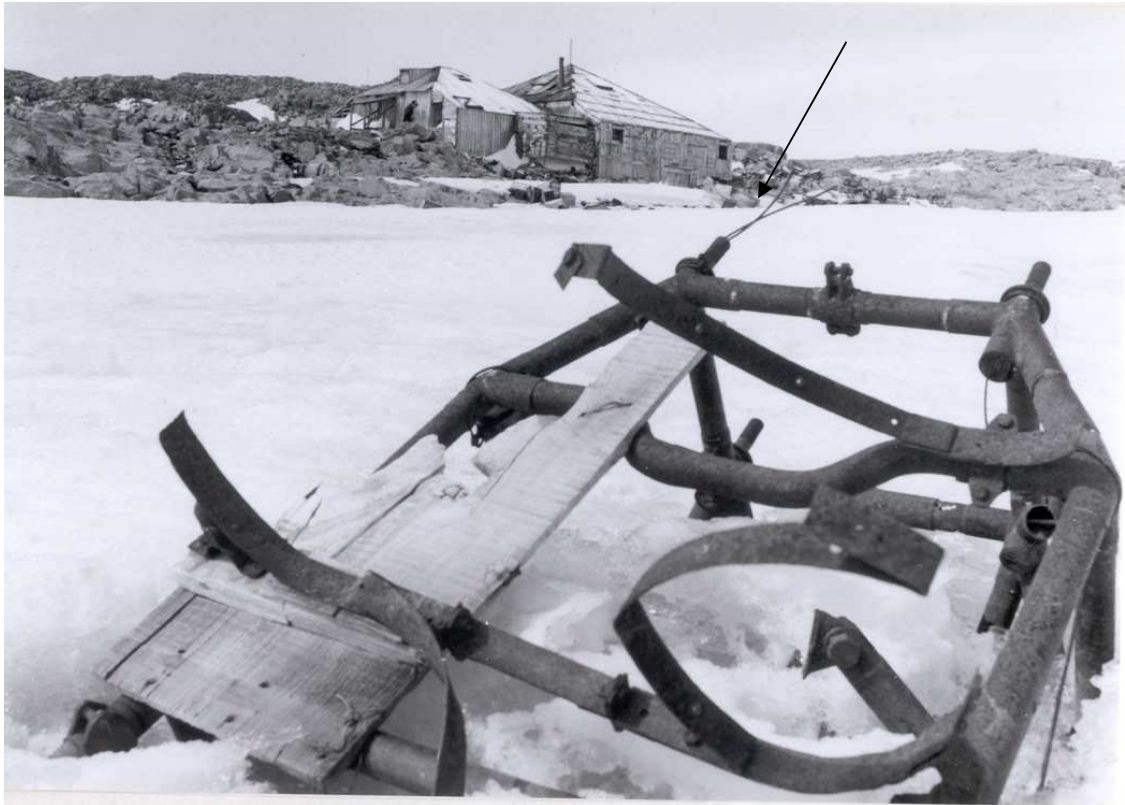
1975: this picture was taken by the AAD photographer Bob Reeves. It is the last known picture of the air tractor frame. It shows about 500mm of the airframe sticking out of the snow. Note the level of the ice at the base of the hut – the crates (arrowed: visible below the R hand wall of the main hut) can be used as a marker to compare with other pictures.

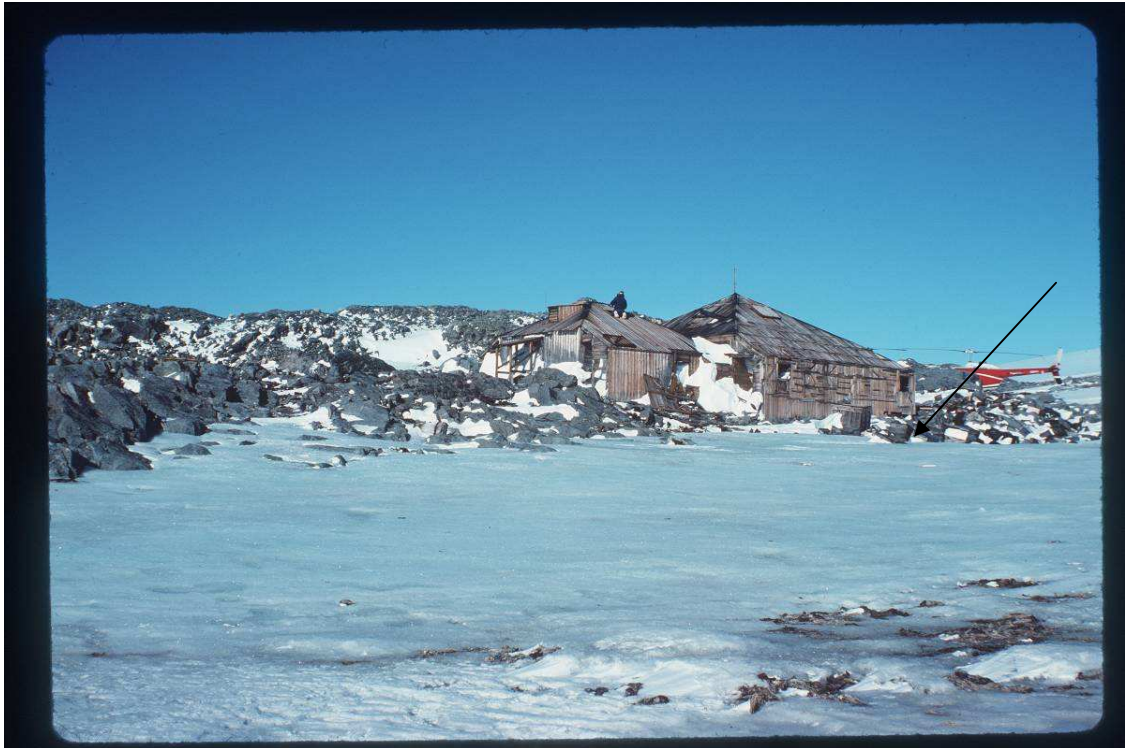
1977: this picture was taken in 1977 by Bill Young, the voyage leader. Dick Lightfoot, the deputy voyage leader, and Andrew Jackson, recently at AAD, were both present on this trip and confirmed that the air tractor was not visible.

It shows the level of the ice was down to the rocks in the foreground, but that the level around the hut was about the same as in Bob Reeves' picture of 1975 (see the arrow which shows the crates in front of the hut, and compare with the Bob Reeves picture above).

This implies that the frame disappeared between 1975 and 1977. The fact that the ice level is about the same as 1975 means that the frame has not disappeared because it was buried by snow. Therefore either the ice melted completely away leaving the frame on bare rock after which it (presumably) blew into the harbour (which is unlikely), or – more likely - it simply sank deeper into the ice.

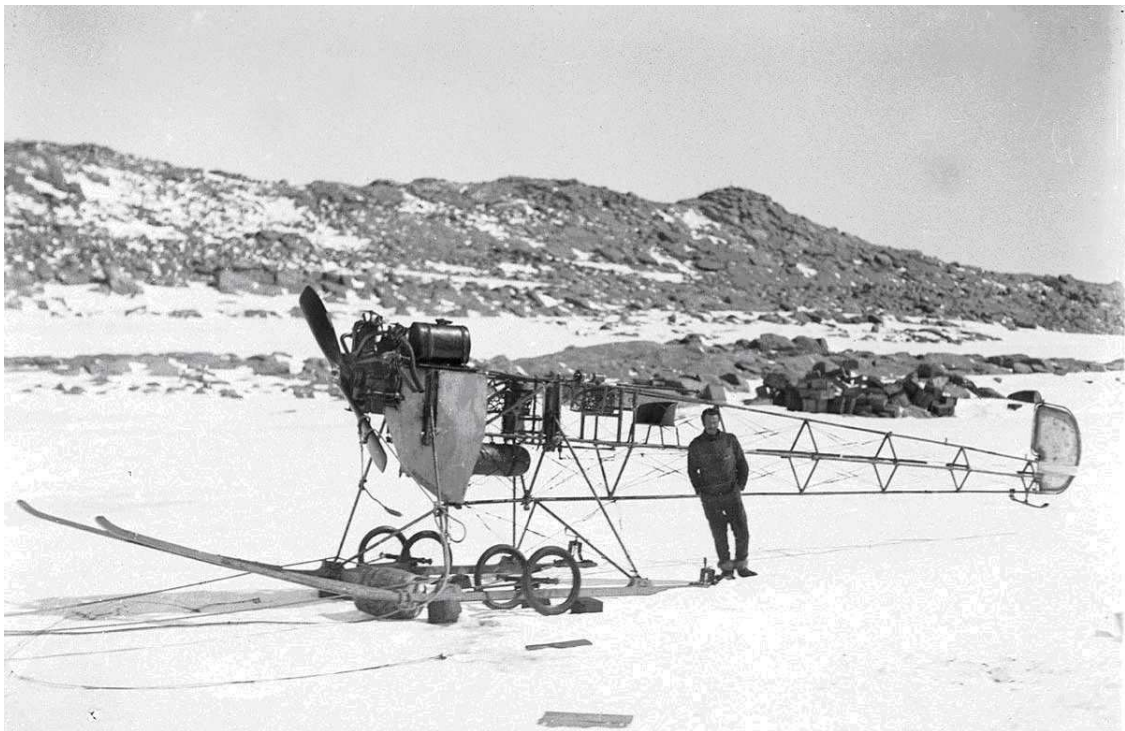
A minimum depth for the ice at the last known position of the frame in 1975 can be estimated from the two pictures below. The frame is about 2.5 metres high (assuming the person standing next to it is about 2m).

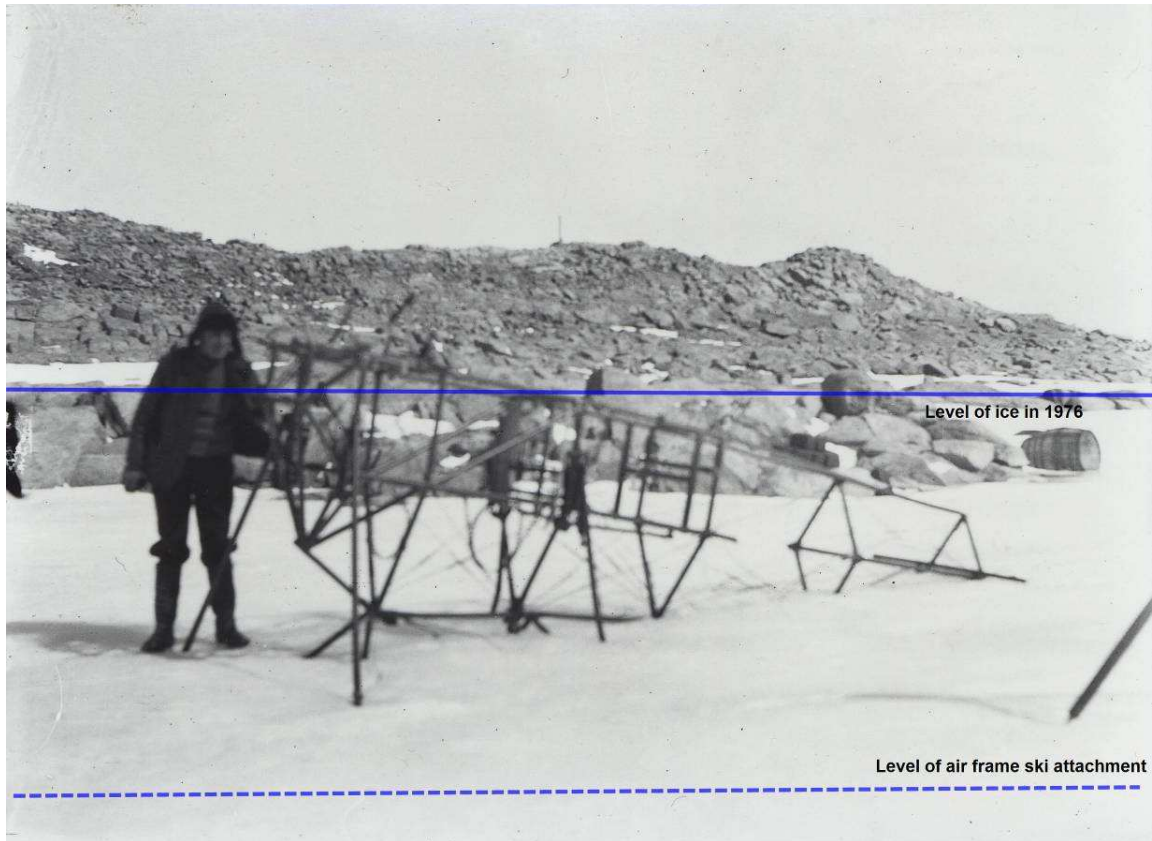
The next picture was taken in 1931 and shows a partly buried frame overlaid with horizontal lines drawn where the 1975 level was, and a lower line at the original level of the skis. There is roughly 2m between them.

Therefore when the 1975 picture by Bob Reeves was taken, the bottom of the frame must have been about 2m below the surface. The picture from 1981 (see next section) shows exposed rocks almost up to the position of the airframe as deduced from transits. This implies that there must be a drop-off or valley in the rocks at least 2m deep just at the edge of the rocks.

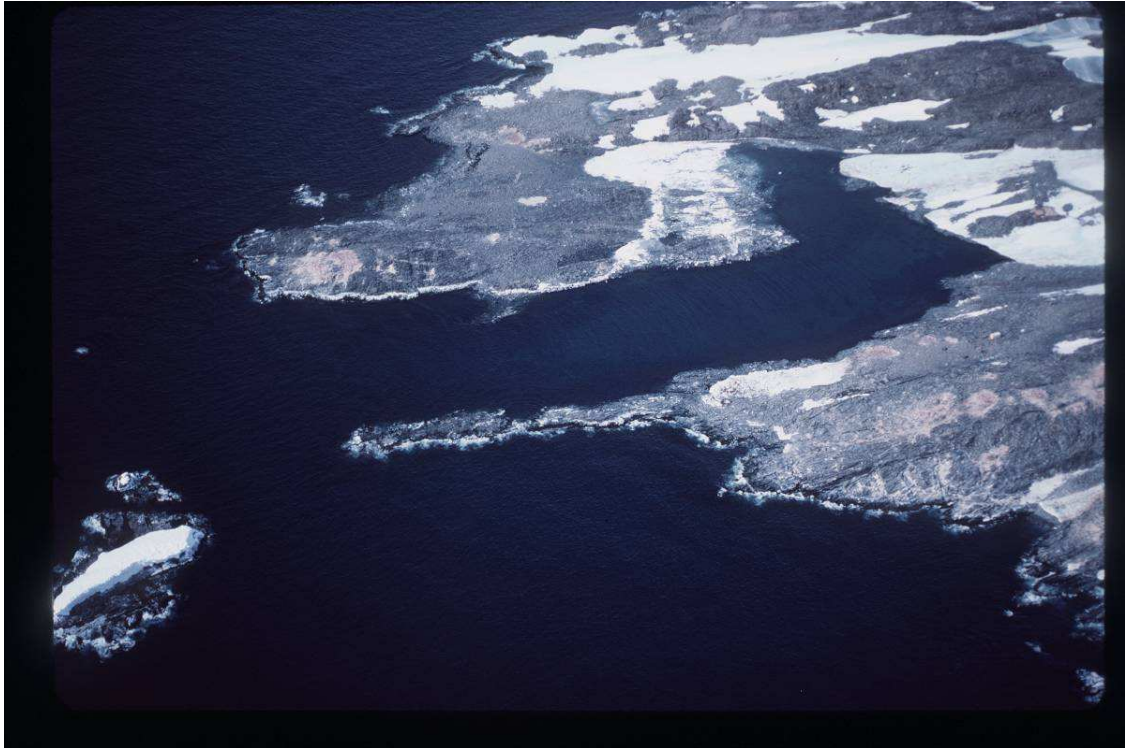
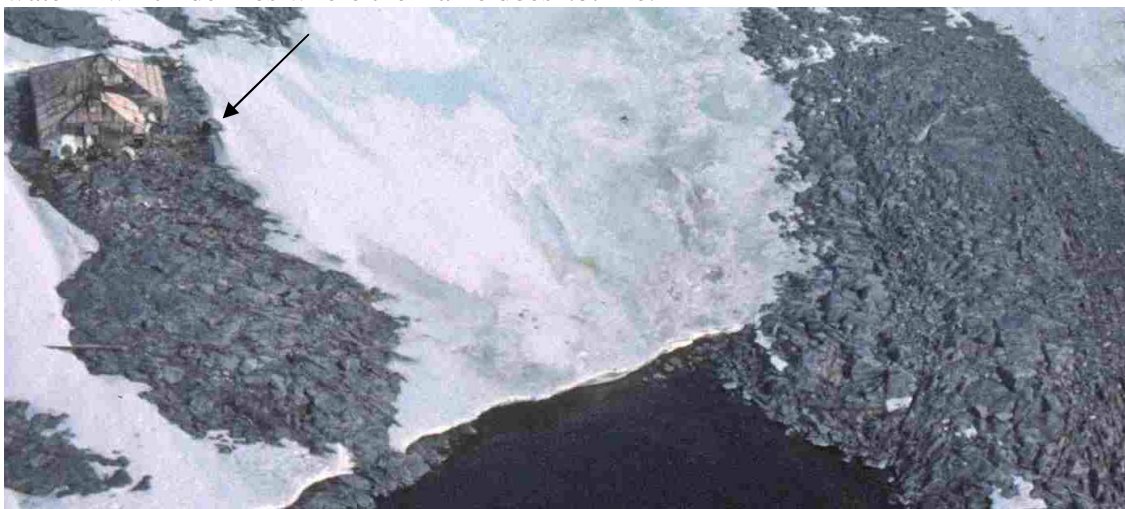
The temperature records suggest that 1980-81 was a year in which the ice melted at Cape Denison, exposing a lot of rock which had not been previously seen. The next two photos show that virtually all the rock around the harbour was exposed.

Of particular interest is the area around the hut where the search was conducted. Again the crates, seen here at the edge of the ice, suggest that the level is not all that much lower than in 1975 and 1977. This aerial photograph shows the extent of exposed rock and water – which defines where the frame does *not* lie.

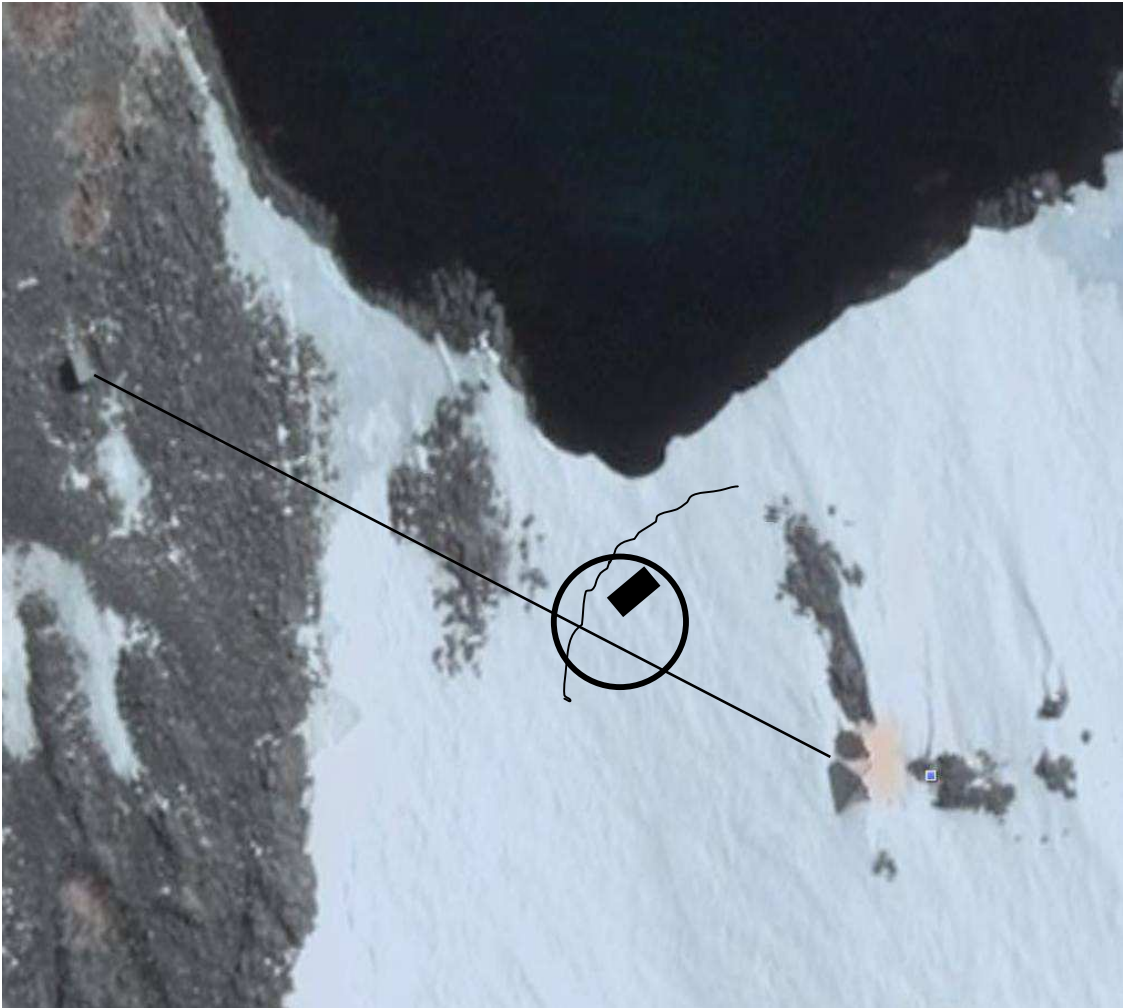
Comparing the 1981 image (above) with the known position of the 2008-9 dig it is possible to establish the boundaries of the rocks, and thus the edge of the area where the frame cannot possibly lie (curved line in the image below). The 2008-9 trench is the small black rectangle.

The area of interest is shown as a circle in the above image.

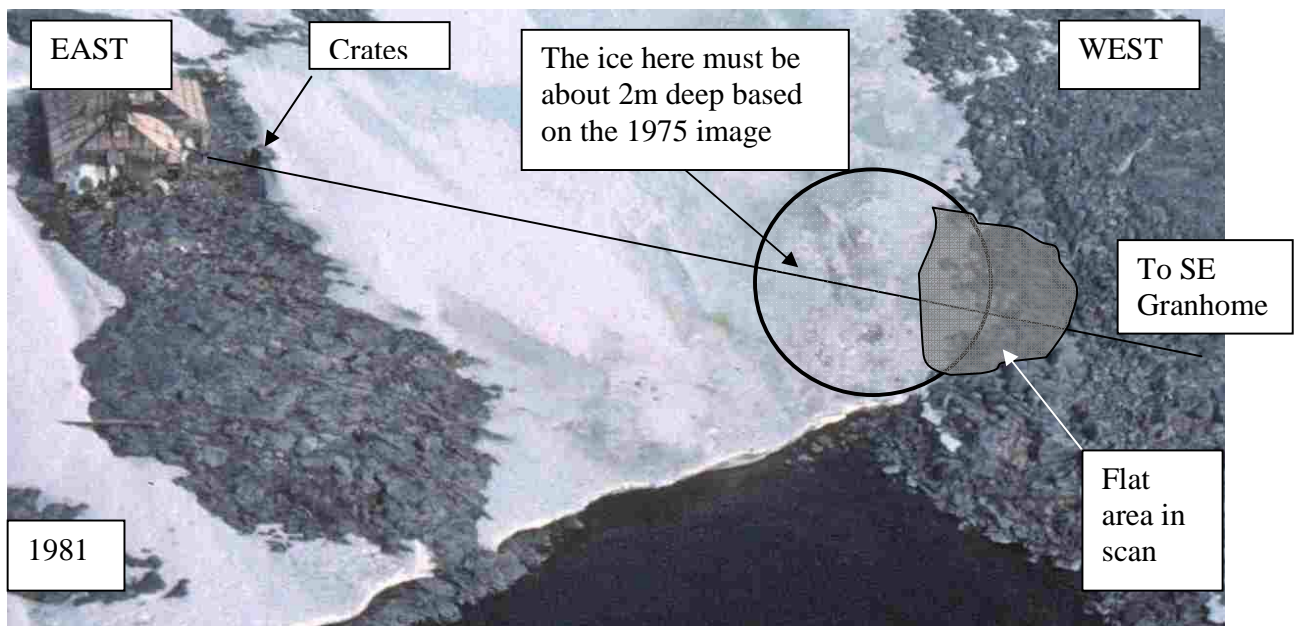
When these measurements are transferred onto the 1981 image an estimate can be made of where the frame is likely to lie with respect to the rocks. The shaded area in the image below at the western edge of the circle corresponds to the flat area found on the 2008-9 radar scan discussed in the next section. The ice must be around 2m below the 1975 surface at the eastern edge of the circle as discussed in the previous section (arrow).

Thus the area where the search should take place this year lies on a line between the NW corner of the main hut and the SE corner of Grenhome hut, at a distance of 50m from the hut.

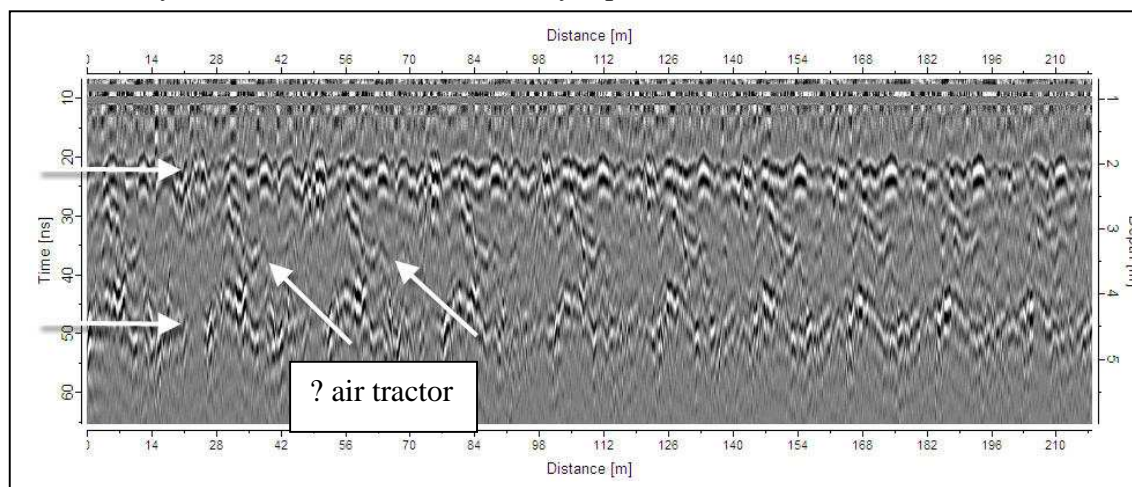
- The radar results (below) show two irregular layers. One at around 2m is probably the ice layer which was found when digging the trench. The other may be the floor of the harbour or of the ‘valley’ in the rocks W of the hut. The two horizontal white arrows in the scan below show these layers.
- In one spiral the results show show an anomaly which appears to descend from the first layer toward the second. This may represent the airframe.

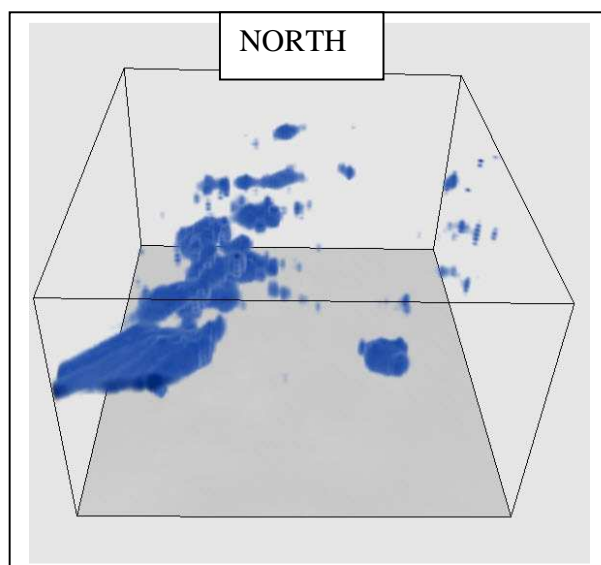
A 3D image of the above was made where the anomalous reflections are emphasised and coloured blue. The upper and lower extent of the box represents the area between the ice layers. It can be seen that the anomaly is a long object (about the right size for the airframe), lying at about the right orientation.

This is a 3D reconstruction of the anomalous reflections shown in the radar trace above. The artefacts shown as “?air tractor” have been coloured blue. The upper and lower borders of the box are the upper and lower ice layers shown as white arrows in above.

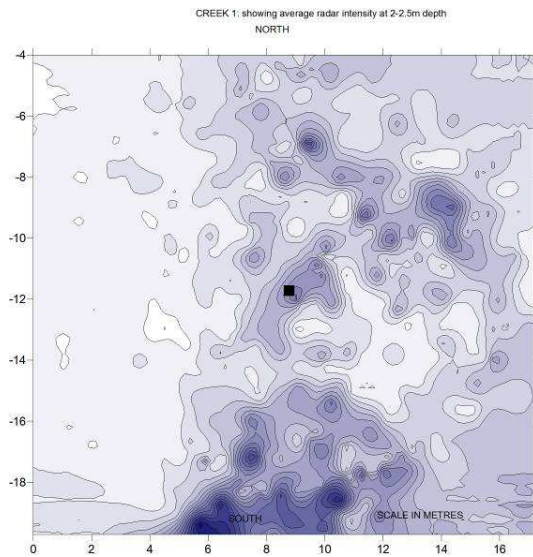
The following image is a contour map of the radar reflections at a depth of 2.5m:

Note the blank area in the left half of this contour map, which is roughly where the bare rocks show in the 1981 image. (The small square in the centre relates to the search technique). This area is greyed out in the image (page 14) showing the area of interest.

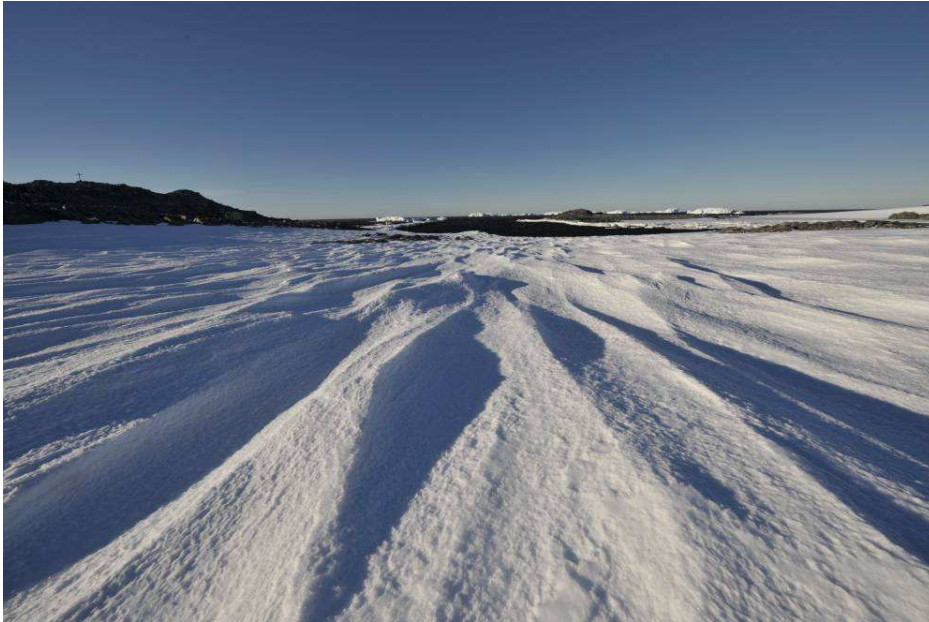
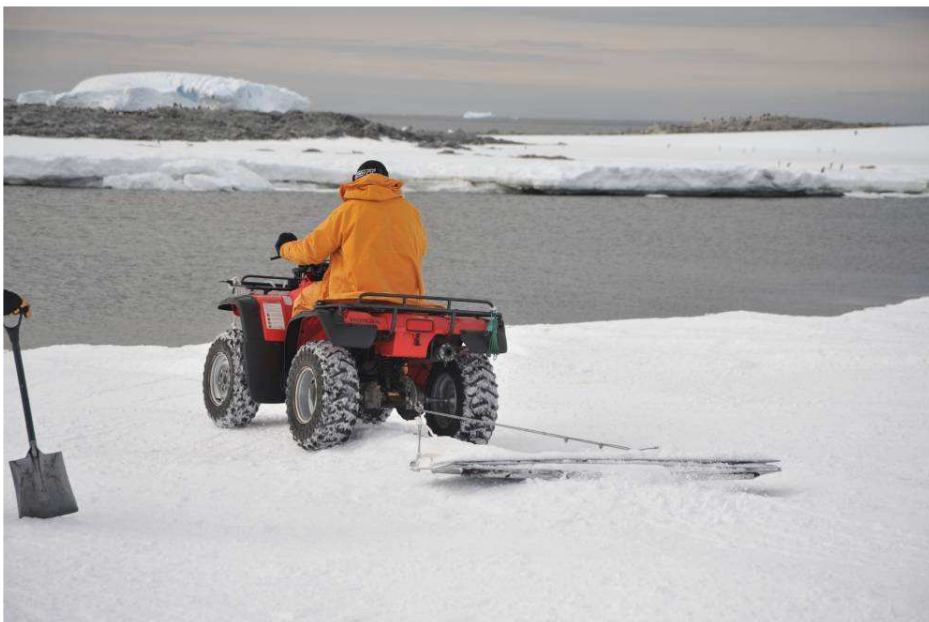
1. The sastrugi needs to be levelled to provide a flat reference surface for the radar aerial (otherwise the scan results will represent surface irregularities). This is done using a steel plate towed behind a quad:

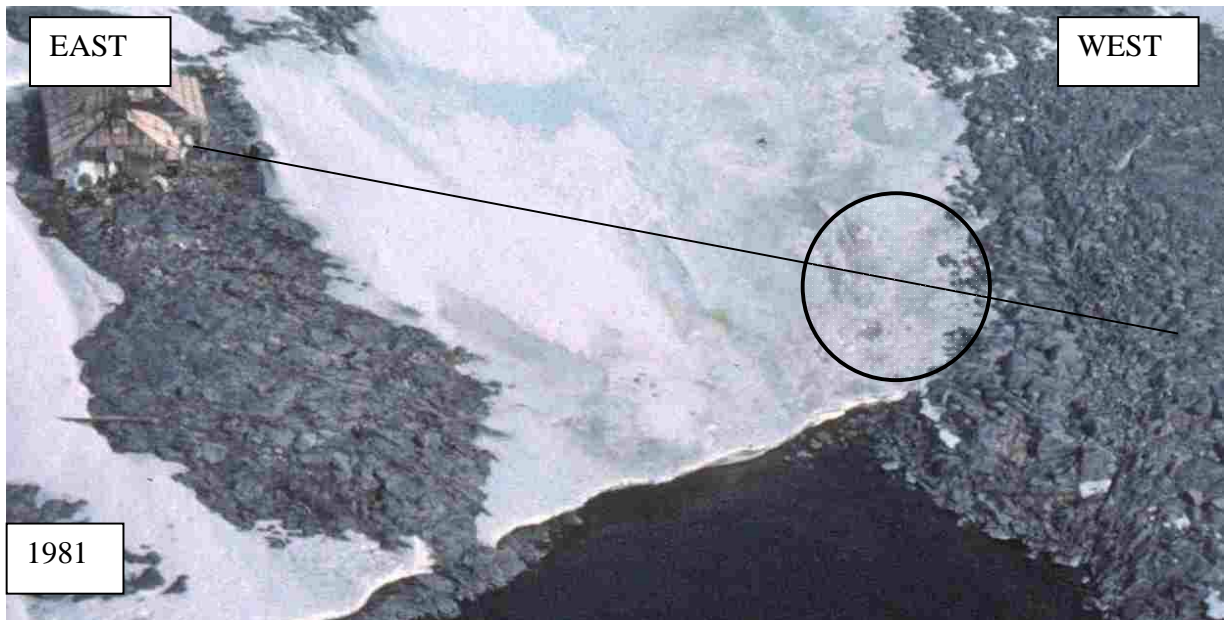
1981 image showing the rocks underlying the search area. This is probably the biggest melt for the past 40 years - the 2008-9 ice covered almost all these rocks. The area where the search should take place this year is circled. It lies on a line between the NW corner of the main hut and the SE corner of Granhome hut, at a distance of 50m from the hut.
