THE SEARCH FOR MAWSONS AIR TRACTOR 2010

Dr Tony Stewart and Dr Chris Henderson

SUMMARY

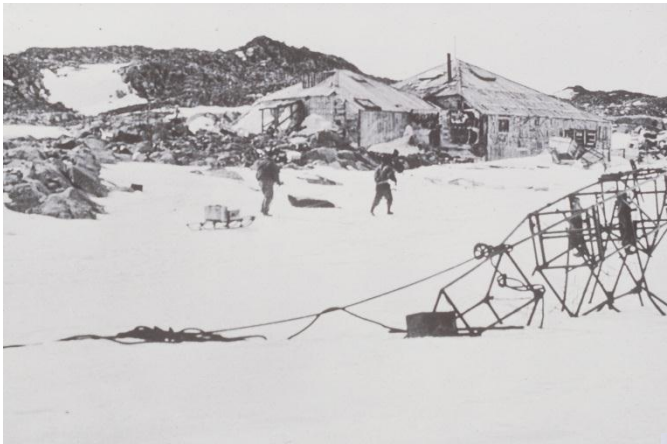
The abandoned frame in 1912. Note the third seat has been removed, and the last 3 segments are gone.

Location of this frame is the objective of the present search.

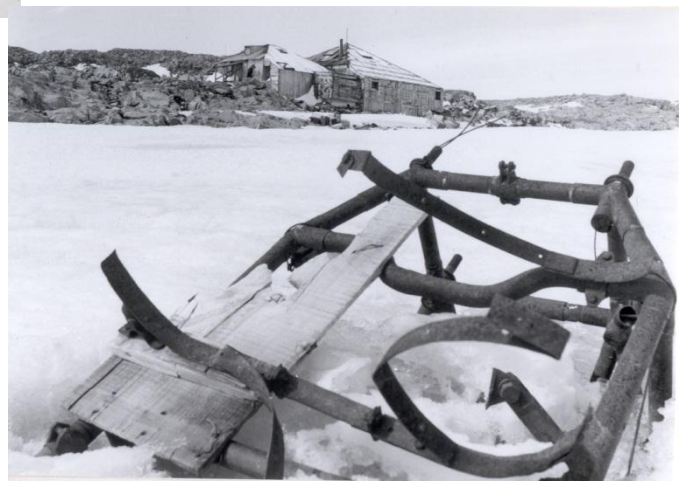
The last known picture of the frame in 1976, taken by the AAD photographer Bob Reeves.

Current evidence suggests that the frame sank in the ice, and is either intact on the rock 3m below present ice levels, or parts of the frame still exist in that vicinity.

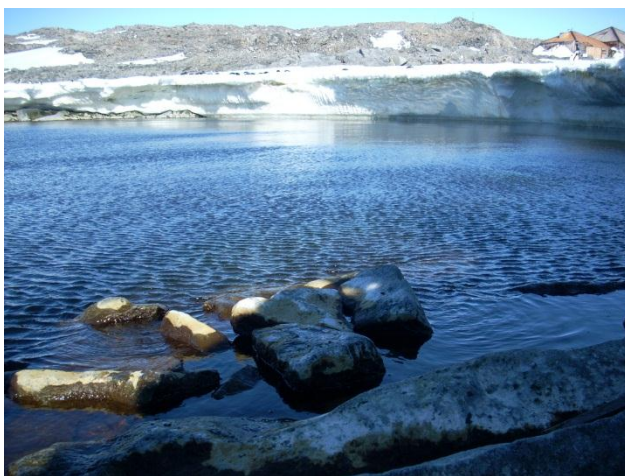
The fragments were found at the edge of the water, just below the air tractor search area – Mawsons Huts can be seen at the top R of the picture.

The fragments were readily identified as being joining sections for the modular airframe – most likely from the last segment of the frame since the outer section of the two centre joining pieces have a terminating bolt on one side.

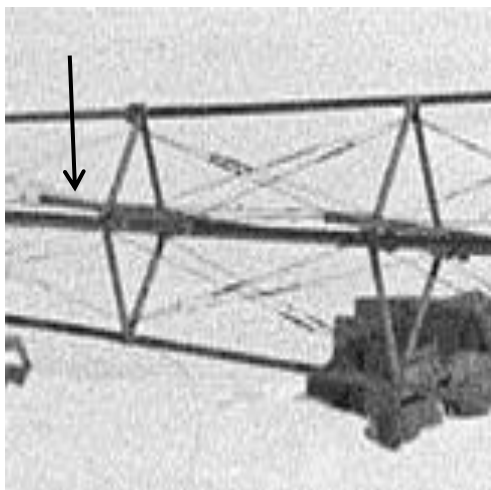
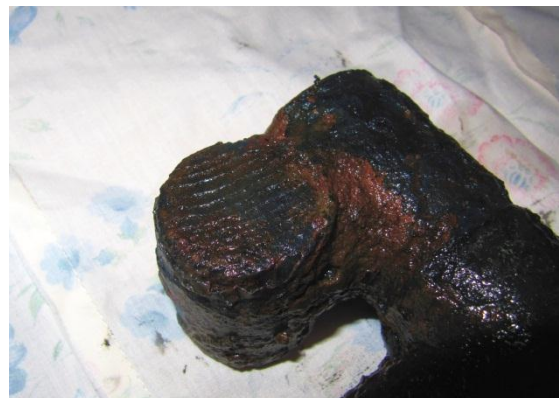
Picture of a section of the airframe showing the overall shape of the segments, and clearly showing the protruding dowel (arrow). On the right is a close-up showing the cut surface of the wood.

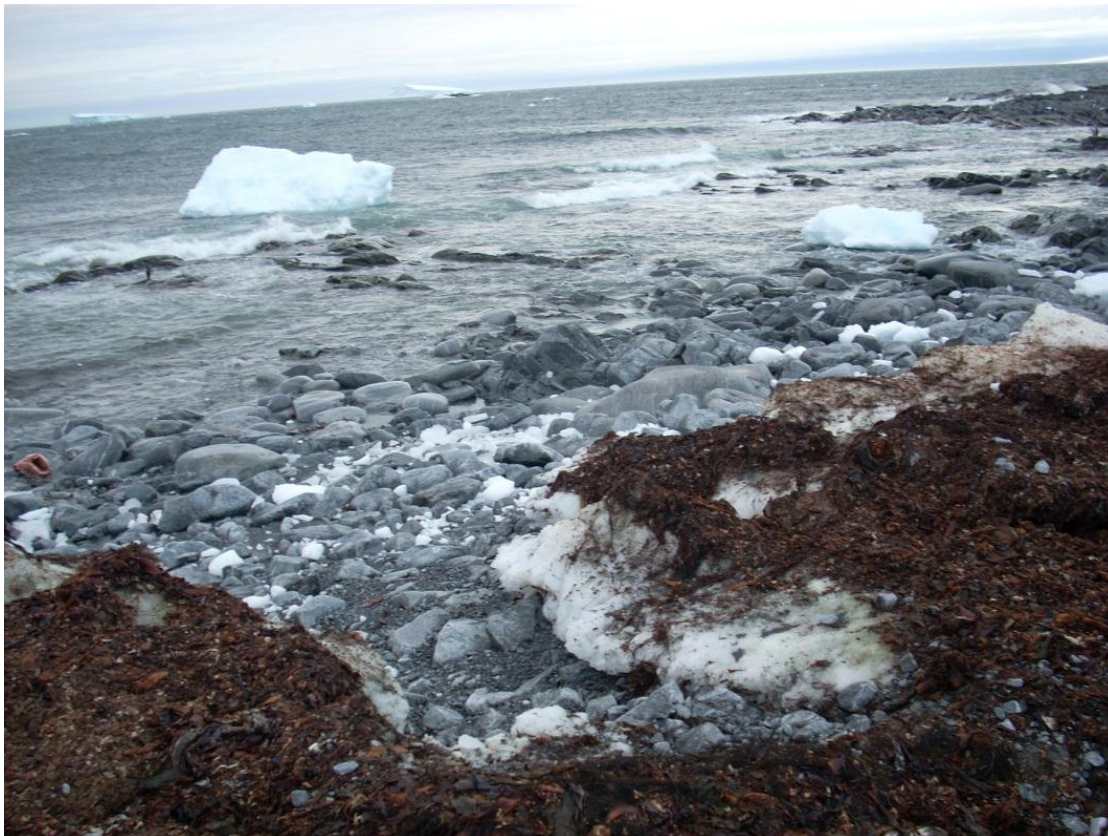
The seabed under the search area probably looks something like this at low tide - gravel, rock, ice and seaweed shelving gently down to the water. The airframe is probably buried in the ice and gravel.

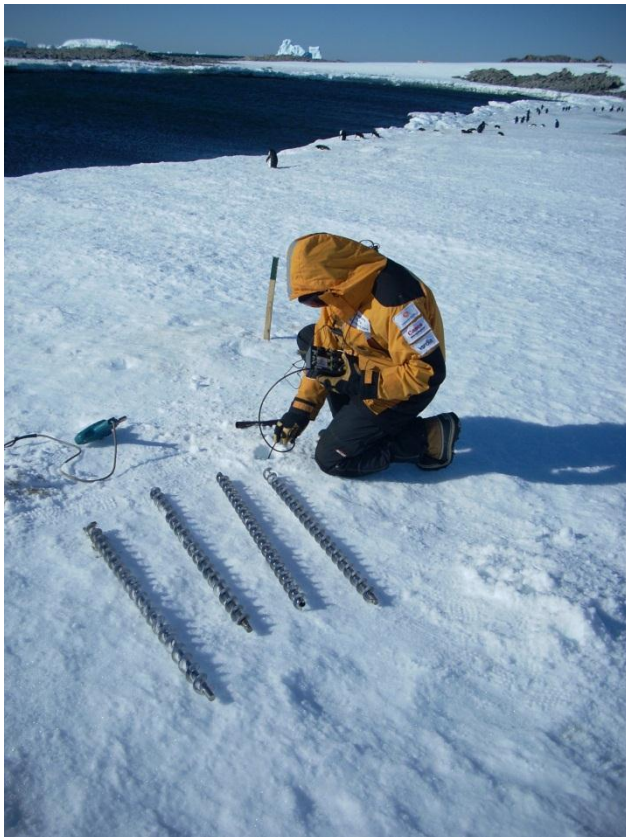
Using the Pulse Induction metal detector. It was important to put the sensor down the hole immediately after drilling since ice particles tended to fall in.

The only positive results were found at 4 holes where the airframe had been located using transects from pictures, from GPR results, and from magnetometry.

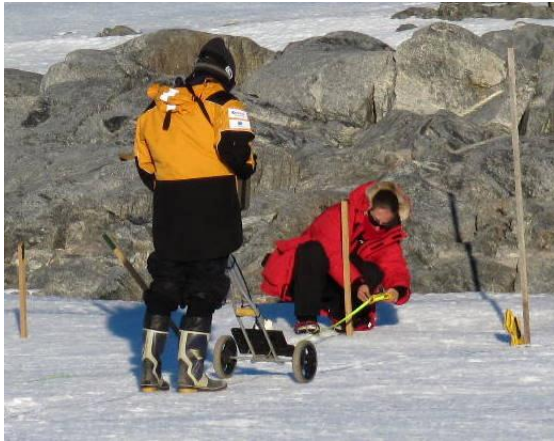
Tony Stewart performs a magnetometer survey. The recording head is in the non-ferrous cart, and Jody Steele holds the tape to provide accurate sampling distances.

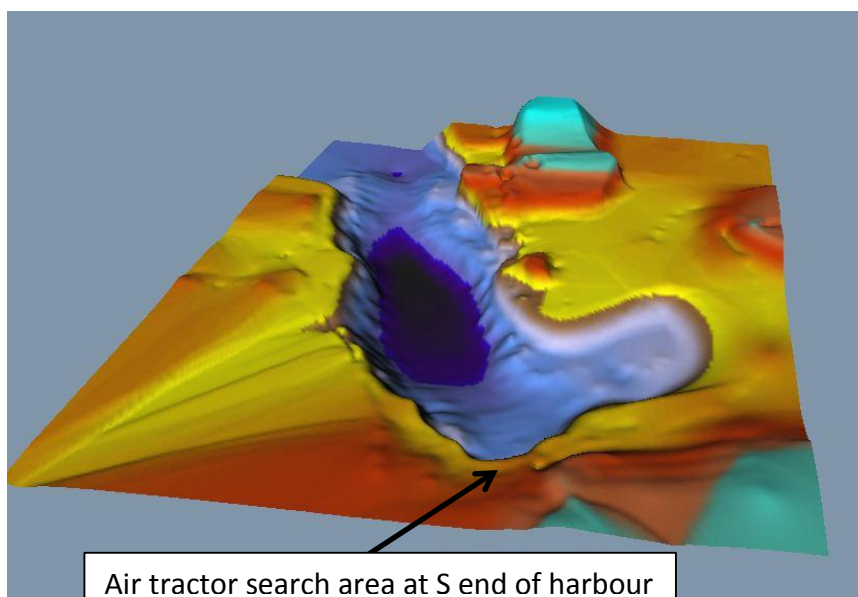
Boat Harbour was surveyed, as is detailed elsewhere in this report. The findings were that the harbour shelves gently to the south, and that there is no trench or discontinuity in the harbour floor into which the airframe could have fallen. The rock under the search area is a gently shelving platform.

Boat harbour survey. It is clear that the harbour shelves slowly from a maximum depth of about 6m to a shallow basin at the southern end. The area where the air tractor is thought to lie is continuous with this profile.
